LEVEL 2

# Your survey report

Property address

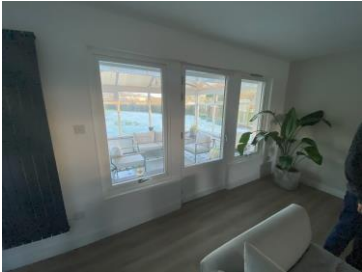
Rear patio doors
