Your survey report

07/03/2025

D2 Roof coverings

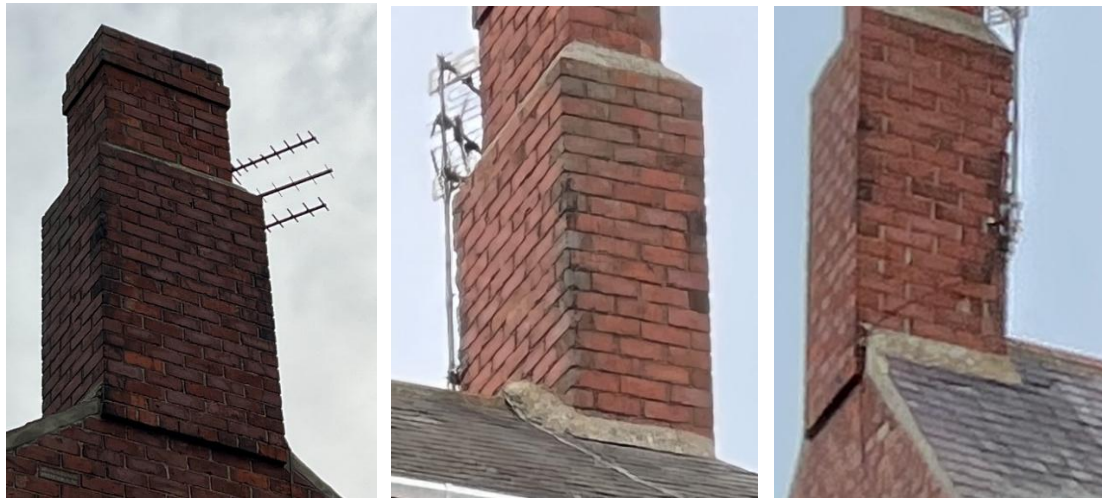
It appears from the ground level that the saddle flashing is cement mortar (flashing to the chimney stack apex which is adjacent the ridge tiles). The cement mortar is likely to crack and dislodge. Should damp or water ingress occur at some point in the future. The saddle should be replaced with lead work.

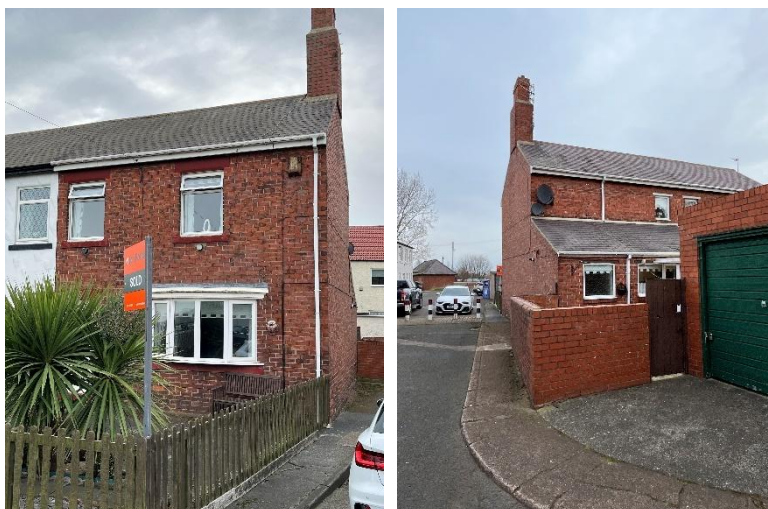
There are a few slipped and cracked slates to the main roof covering. The covering should be repaired and checked.

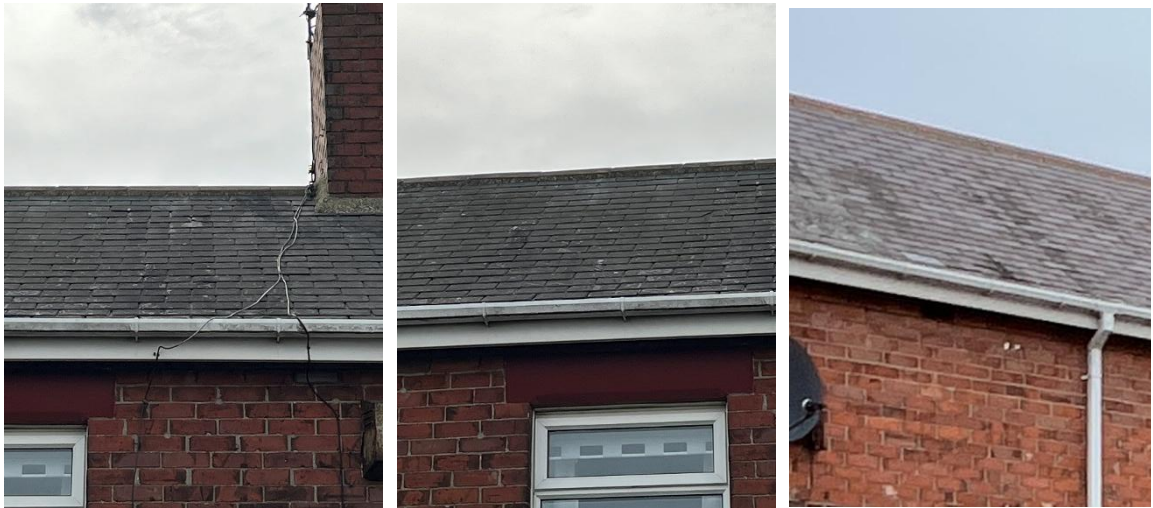
The flat roof conservatory construction abuts the rear mono pith roof and the joint has been formed by inserting the roof felt under the original slate roof, this has displaced the seating of these slates and could allow moisture to enter the roof structure.

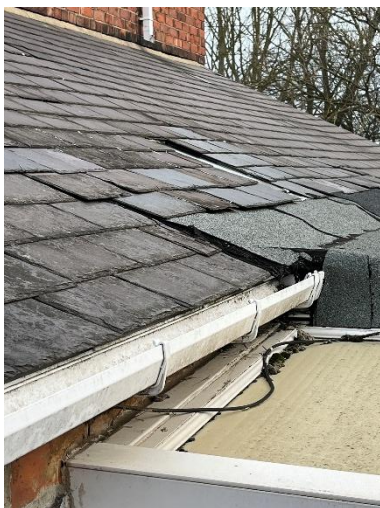
There was no ventilation provision within the kitchen roof. Timber roof structures require cross ventilation to ensure the timber remains free from rot and decay. Ventilation channels should be provided.

It is advisable to appoint an approved and reputable roofing contractor to assess the entire roof covering (including elevations and extensions) condition, ventilation, repair costs and remaining product/material lifespan before the exchange of contracts.

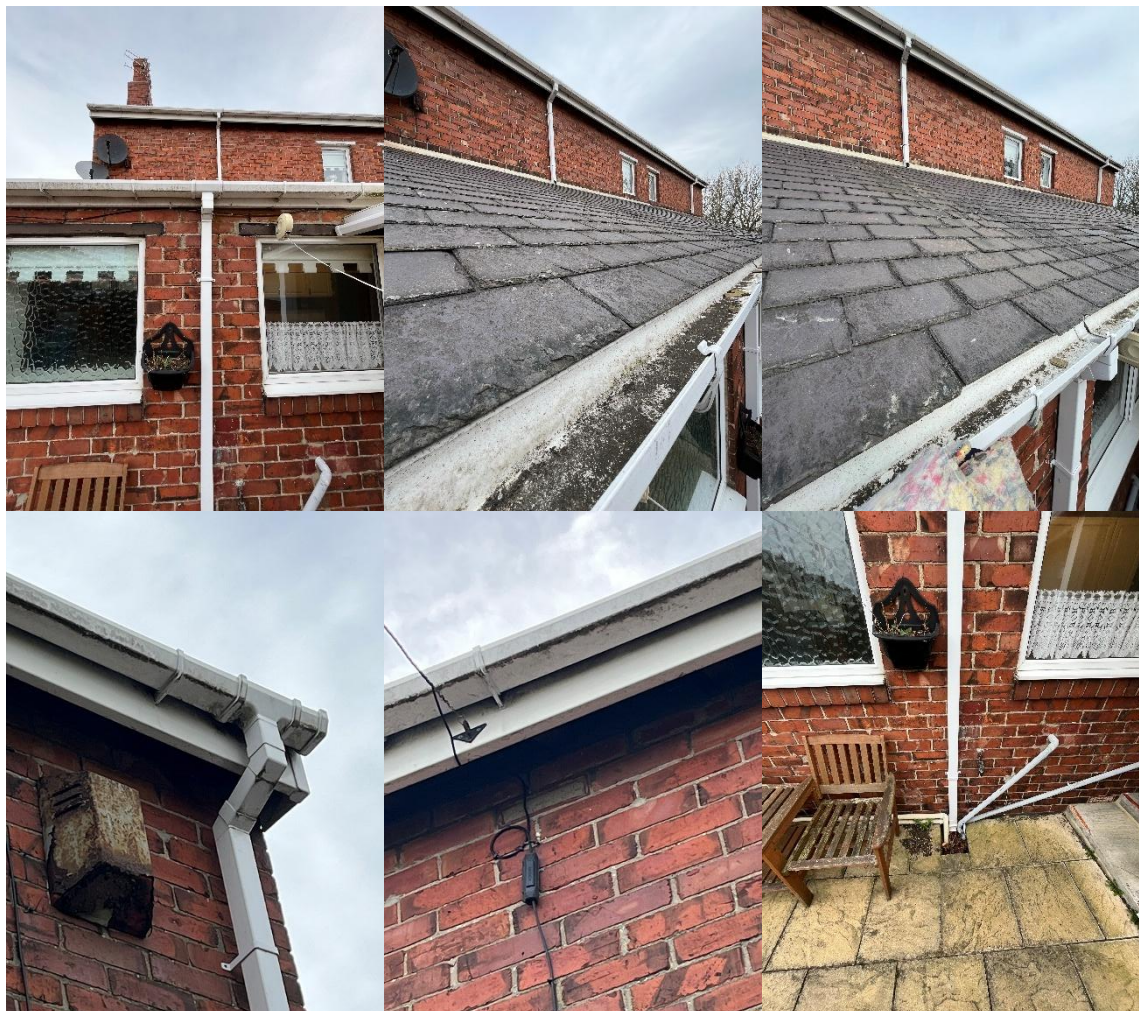
The guttering and downspouts appeared to have moss and algae growth. These should be cleaned at the first opportunity to prevent further growth which may lead to seals and gaskets becoming damaged.

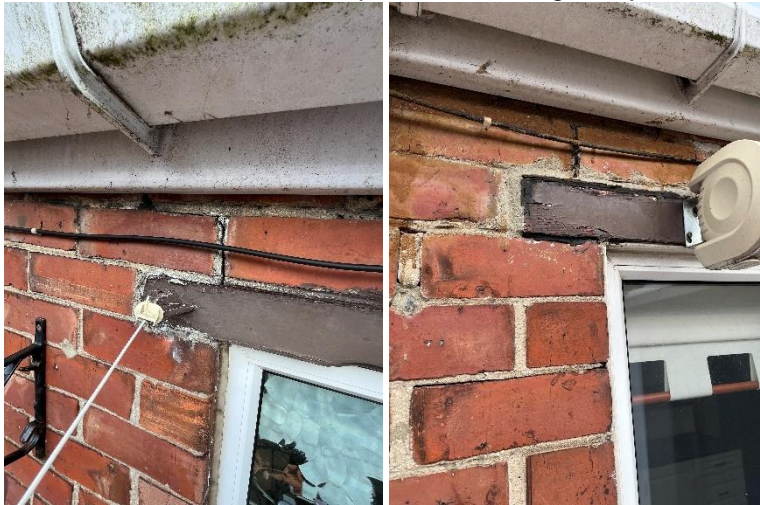
Although considered minor due to the limited loading of 3 course of brick. The masonry has diagonal cracking above the window opening. Diagonal cracking can indicate lintel deflection or structural movement. A lintel supports the masonry above an opening such as a door or window.

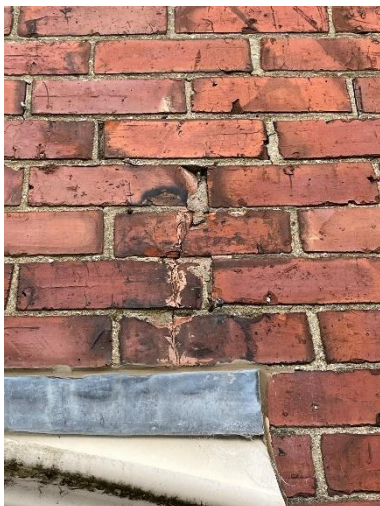
There is vertical cracking to the masonry above the front bay window opening, the cracking extends to several courses of the masonry. It cannot be determined from the survey the cause of this but may be due to the installation of the new window

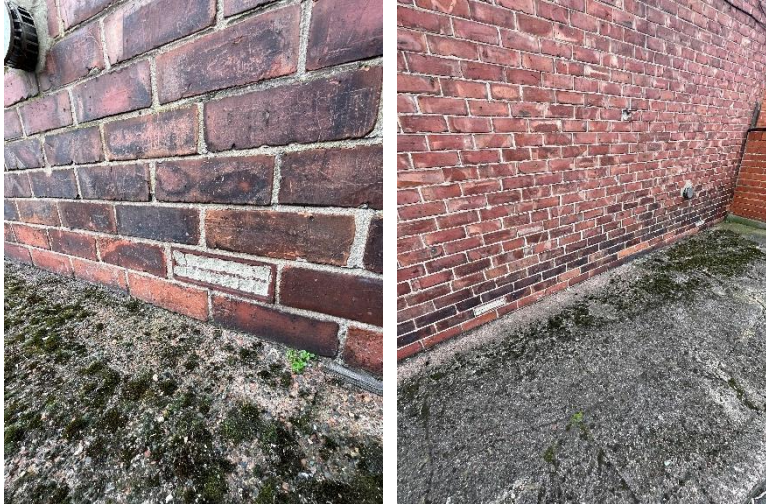
The air vents to the side elevation have been blocked/filled with mortar pointing. Air vents prevent humidity and condensation forming beneath a suspended floor. It is advisable to install clear these air vents at the earliest opportunity. The timber floor joists should be checked to ensure rot and timber decay hasn't started.

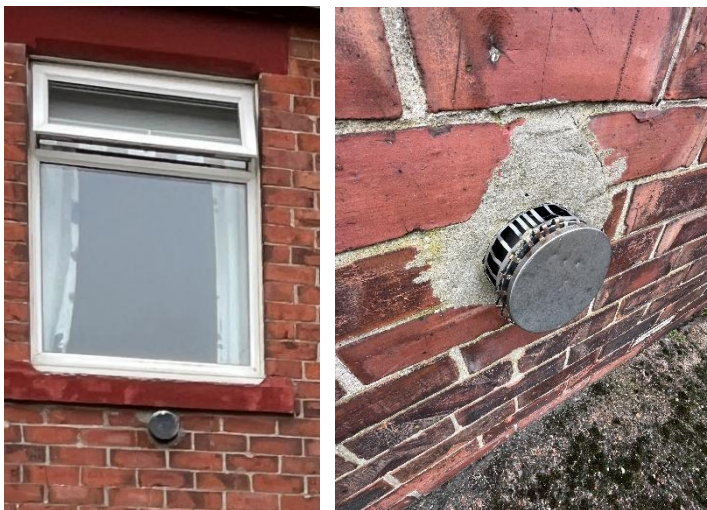
There are redundant gas flues to the front and side elevations. The openings appear to have been filled internally. Openings in the masonry wall can allow moisture to enter the cavity unnecessary causing damp to the internal walls. These should be removed and the opening closed by a suitably competent person.

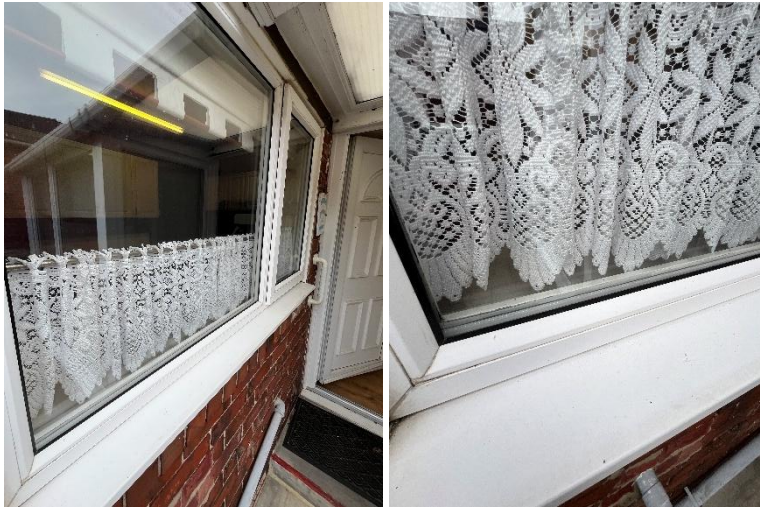
The window frame has external glazing beading which is no longer used in a modern window design. The external beading and double-glazed units can be removed externally. It is advisable to make enquires with the proposed property insurance company, as external glazed beading may be an exclusion from an insurance policy. I would recommend replacing the window frames for property security.

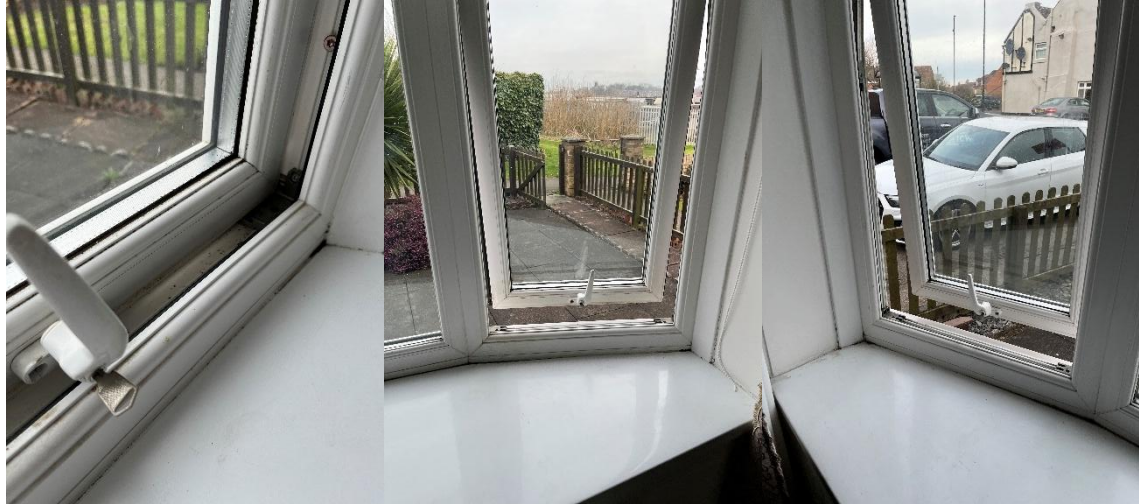
The side openers require adjustment as the opener is catch the frame. Openers that do not close into the frame rebate correctly can damage the opener hinge, double glazed unit, and the window frame.

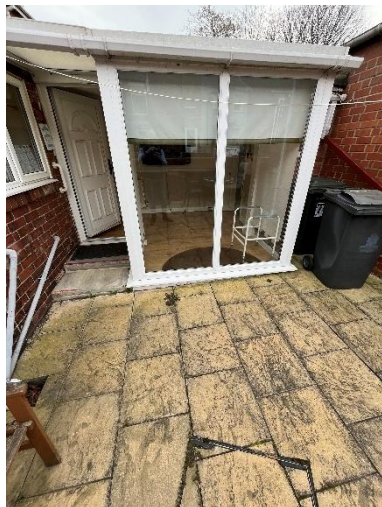
Glazing that building occupants are likely to come into contact with must meet one of three requirements: If broken upon impact it will break in a way that will not injure anyone, resist impact without breaking or be shielded or protected from impact. The full height glazing units did not have any Kite marking visible and should be checked for their suitability in regard to glazing in critical areas

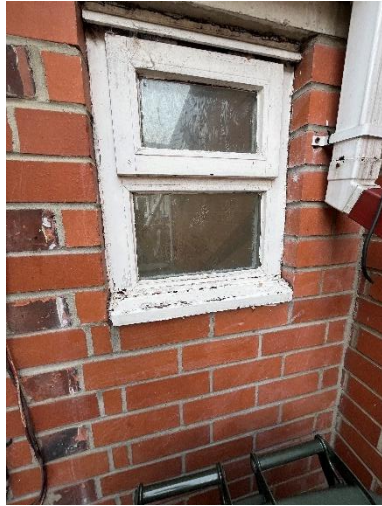
There are sections of the window that are decayed and rotten, and the extent of which is unknown. Sections of timber rot can be removed and spliced with new timbers. I would recommend obtaining estimates of works from competent contractors before the exchange of contracts as it may be more economical to replace the window rather than carrying out repairs.

It is recommended to seek advice from a suitably qualified and experienced 'competent person scheme', such as a FENSA window and door installation company to assess the window condition and remaining service life of the windows against repair works.

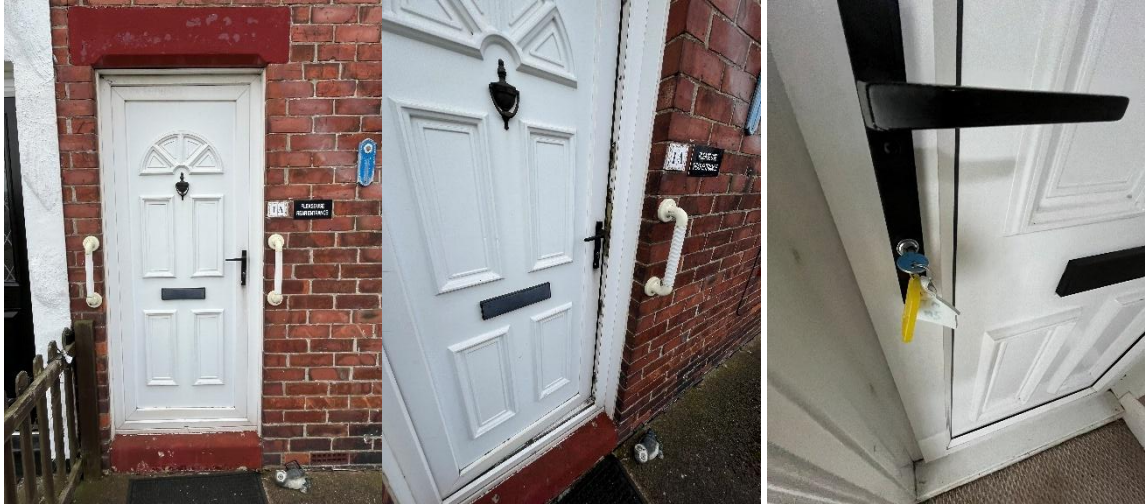
The front door does not close into the door casing correctly. The door appears to have dropped and catches at the threshold, or the original installation was out of alignment (plumb) from the door to the casing. The doors may need to be replaced or adjusted by a competent person.

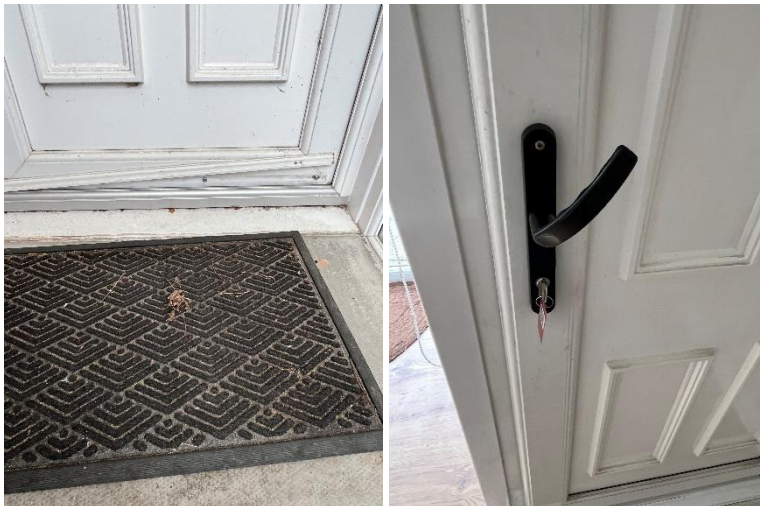
The rear door deflector is loose and should be re fixed. A deflector projects rainwater away from the threshold, which helps to reduce the door gaskets from becoming saturated and perishing. The UPVC deflector should be installed by a competent person.

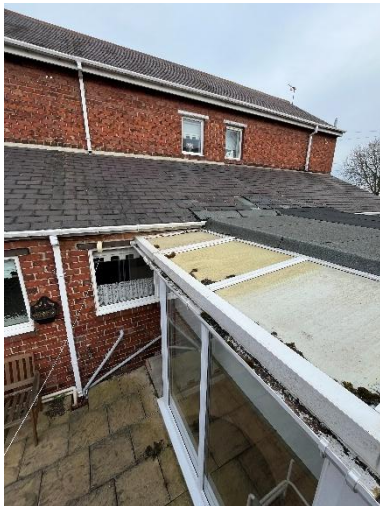
The roof covering is a mixture of Upvc panels, and a flat roof felt. The joints should be checked to ensure moisture does not enter the building around joints.

The conservatory roof requires cleaning. Moss and algae have stained the roof covering and should be cleaned off to prolong the roof covering. A mild detergent should be used or preferable the seek advice from the conservatory manufacturer. Strong detergents can damage the covering.

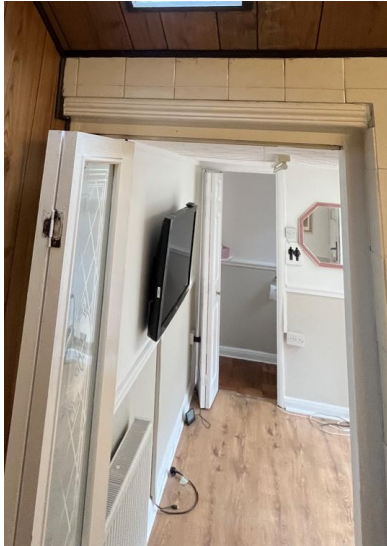
The conservatory is not separated by external doors to the main property. The conservatory may now require building regulation approval and checks should be made with the local authority building control. The conservatory must be separated with external doors to be exempt from building control approval.

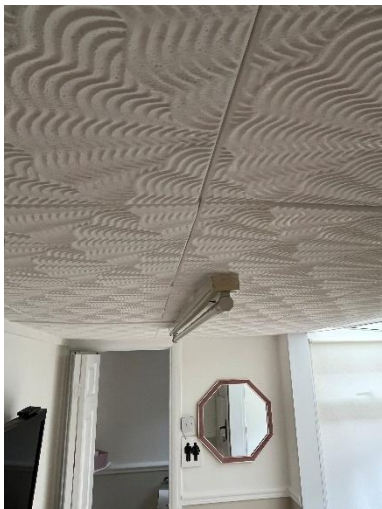
The ceiling is covered with polystyrene tiles. Polystyrene ceiling tiles and coving can be a major fire risk. An out-of-control house fire can produce poisonous gaseous fumes and the plastic in the polystyrene can drip and burn your skin as it falls. I would recommend replacing all polystyrene tiles with a plasterboard ceiling.

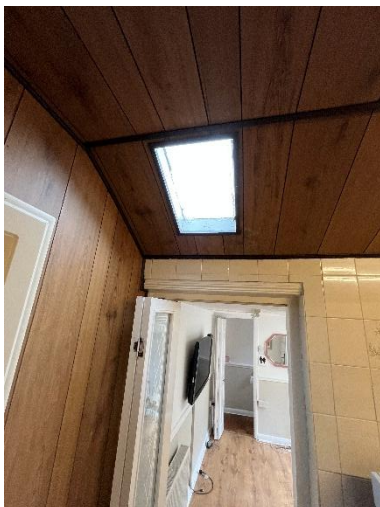
The velux window has timber decay. The timber should be checked and treated or replaced. Timber decay will lead to water ingress into the room.

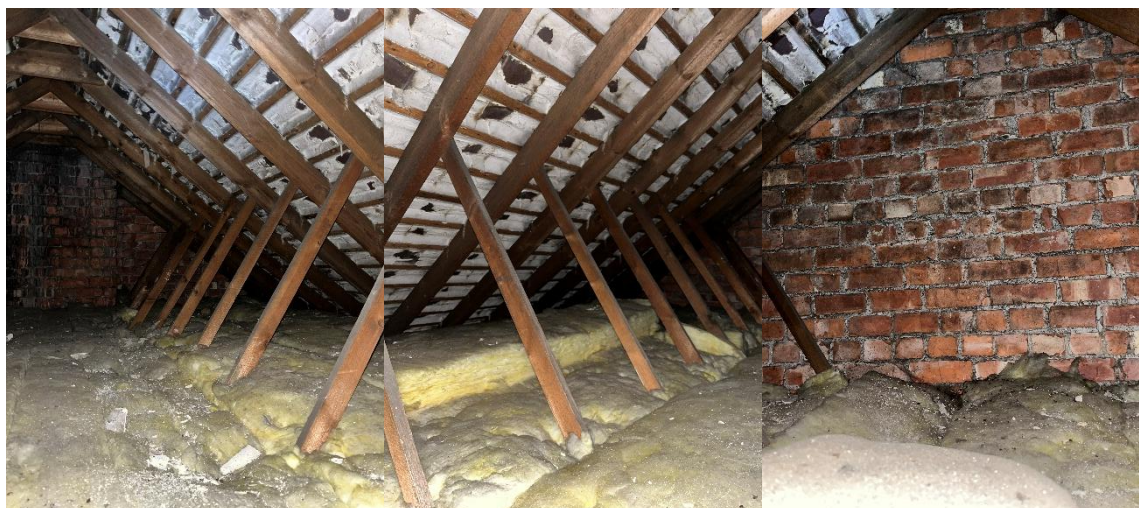
The main roof does not have an underfelt. A felt is designed to act as a secondary rainwater barrier to the roof covering. Water ingress from the roof covering can cause timber decay and damage to electrics and to the ceiling plasterwork below. It is advisable to 're-roof' the main roof with a breathable felt system and new battens. The roof structure timbers should be examined once exposed.

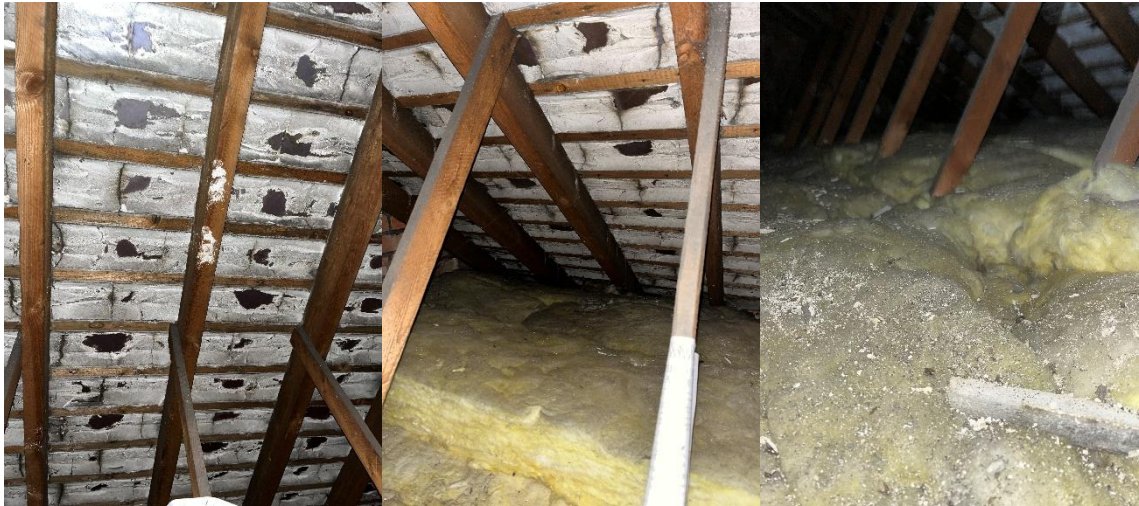
There was no cross ventilation from the eaves as the insulation was blocking air flow. The insulation may become wet and will lose thermal efficiency. In severe cases of inadequate roof ventilation, excessive condensation can form, leading to timber decay and rot to the roof timber structure. A qualified and suitably experienced person should be appointed to advise on ventilation requirements, such as eave spacers.

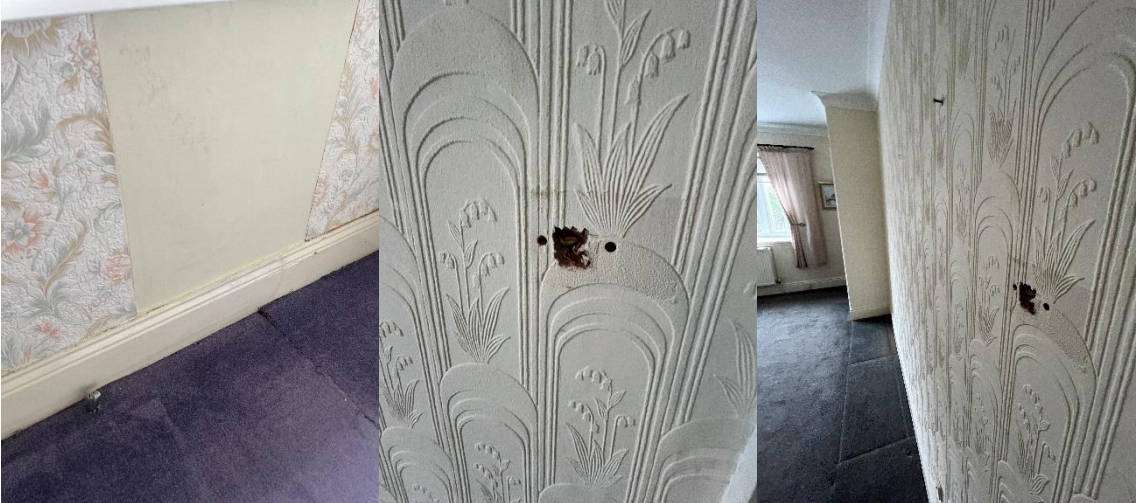
There were several holes to the plaster and partition walls. The wallpaper will have to be removed in this area for the plaster board repair to be carried out. The hole may be filled with a back board and filled and sanded over.

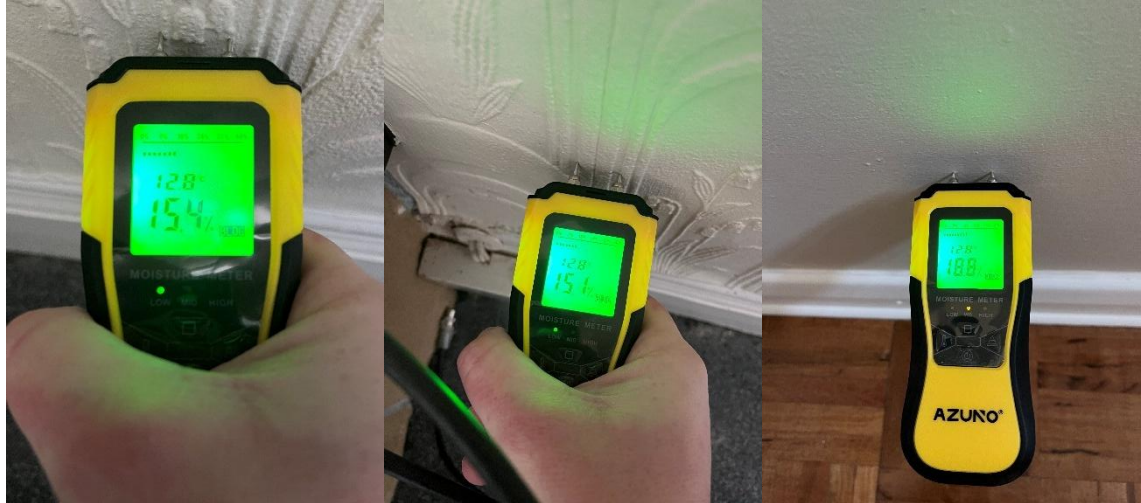
A damp reading was undertaken to the ground floor walls which showed a consistent, acceptable moisture reading level of 15 percent.

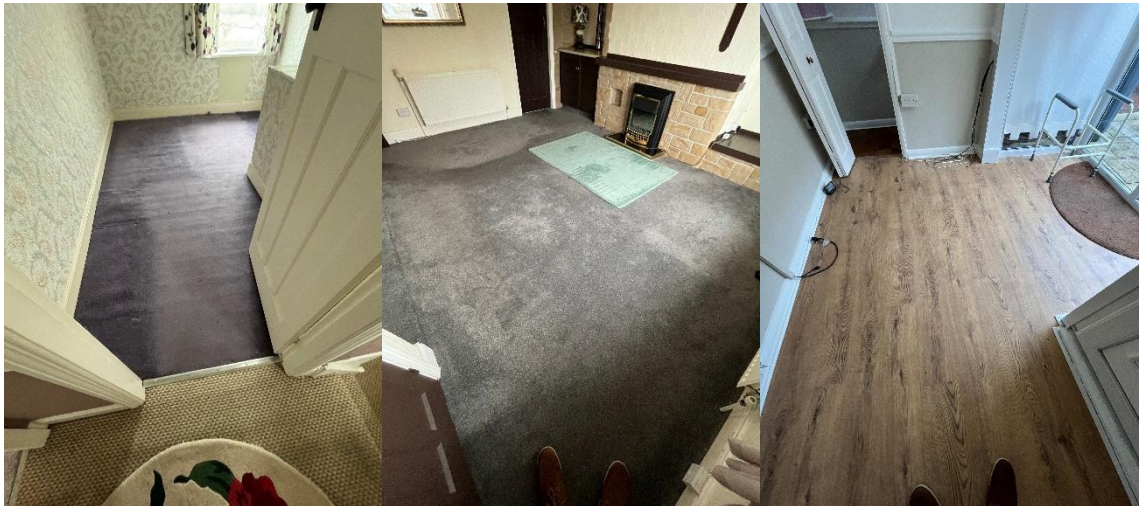
Some creaking and movement to the floors was noted below the covering which is typical within a property of this age, flooring may need to be refixed. Care should be taken when fixing flooring as wires and pipes are often hidden in floor voids and can be easily damaged.

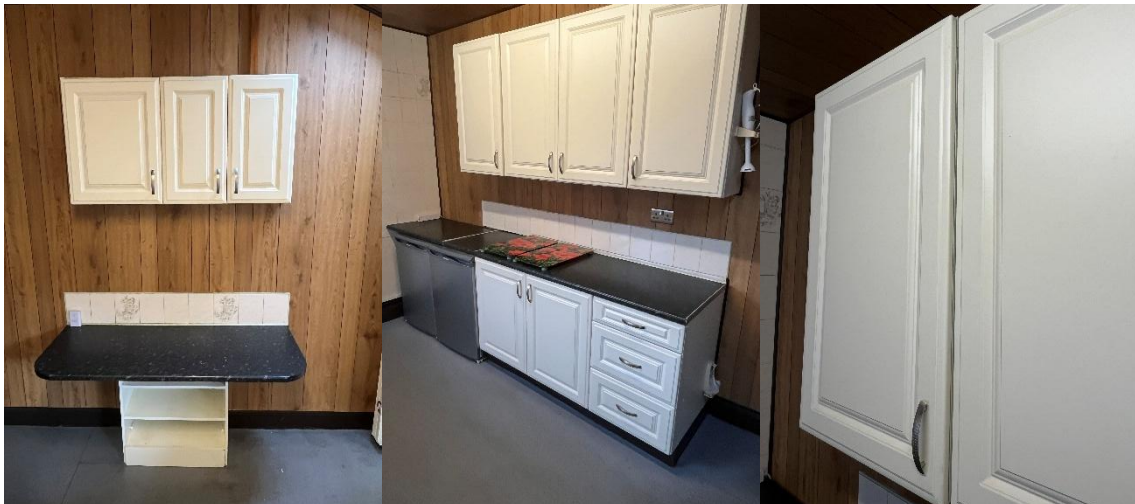
The kitchen is dated and requires repairs to worktops and units it may be more beneficial to replace rather than repair.

Several cupboard and drawer fronts require realignment as this can cause the front of the unit to snap away from the draw shelf unit during use.

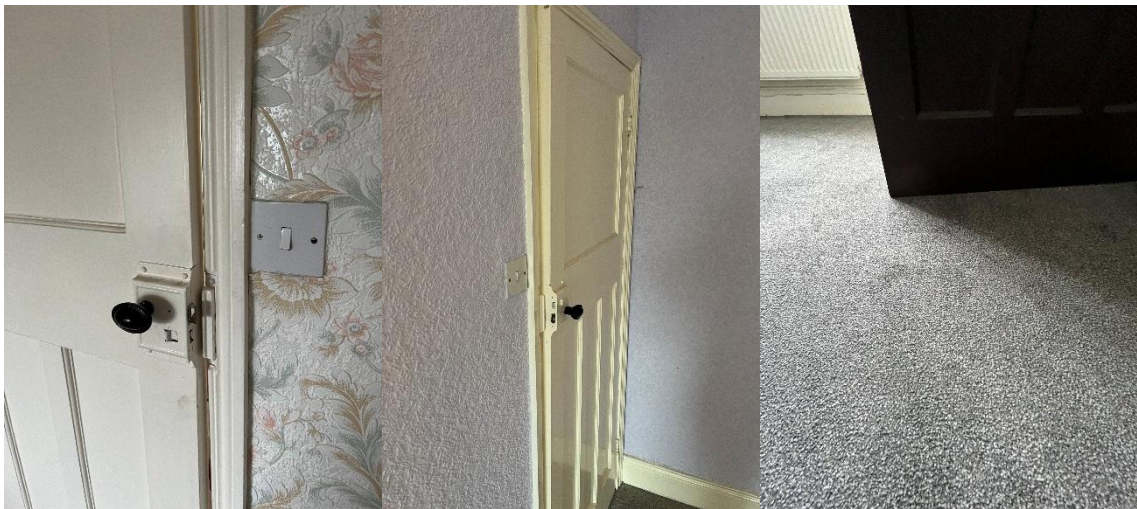
There are several doors that do not close correctly. The doors may need to be re-fitted/eased by a competent person.

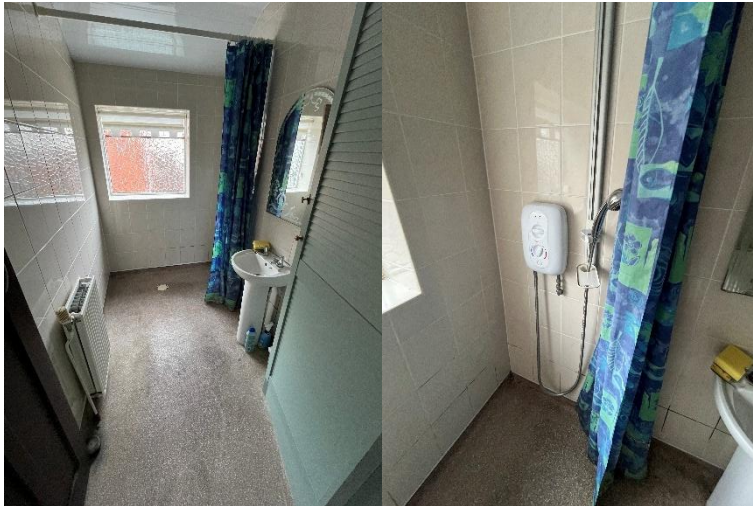
The shower head and bathroom fittings were not tested during the inspection. The shower head should be suitably cleaned, and hot water should be run through the system to ensure bacteria such as legionella is not present.

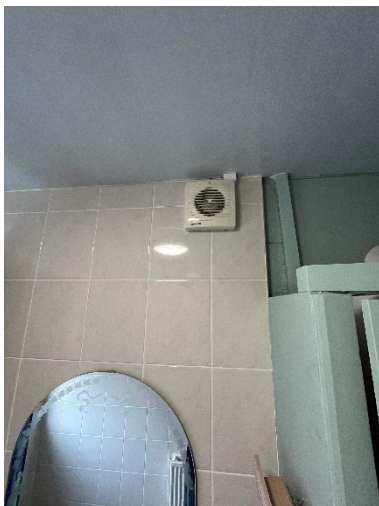
The extractor fan did not operate when in the on position. An extractor that is not operating correctly can allow excess moisture to build up within the air and circulate around the property structure. Once the warm moisture laden air, meets a cold surface, saturation of surface capillaries can occur leading to mould spores. Should the extractor not operate correctly when in use, a suitably qualified and experienced person should be appointed to provide and install a suitable extractor.

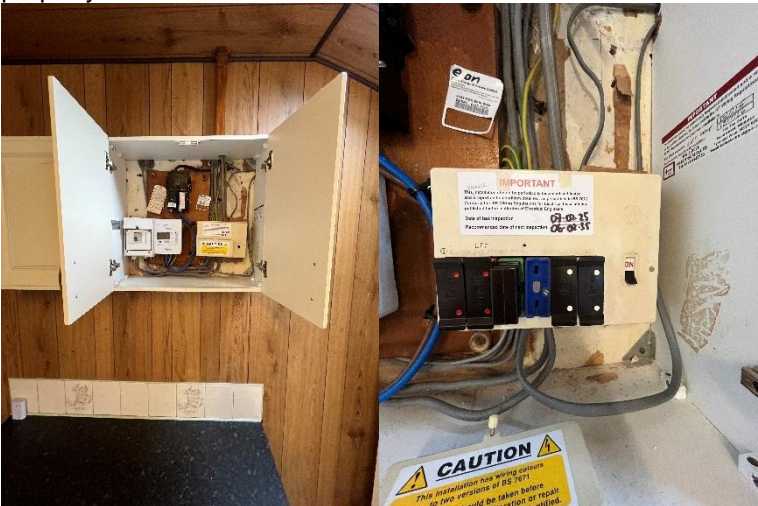
The fuse box is dated, and it is likely that this needs to be replaced with an RCD protected consumer unit.

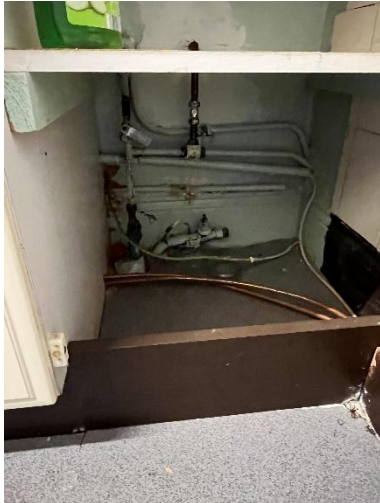
A mains water supply is provided to the property. Where accessible the pipework appeared to be in plastic and copper. You should ensure that the stopcock should be kept accessible so that it can be accessed in the event of an emergency to cut the water supply off.

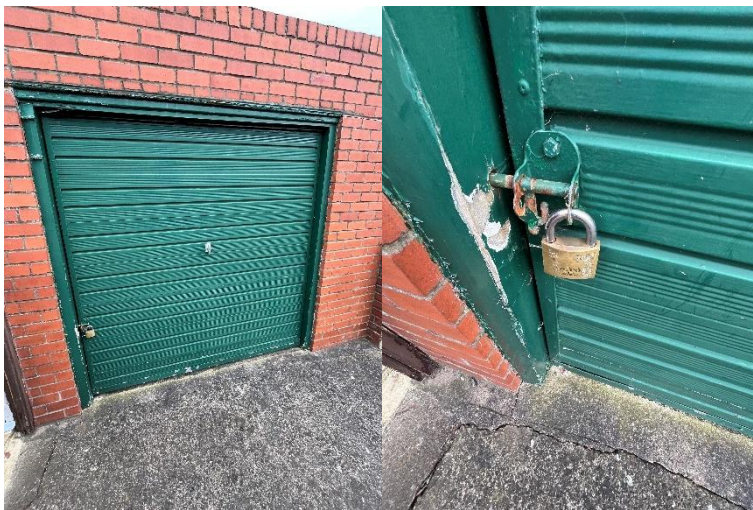
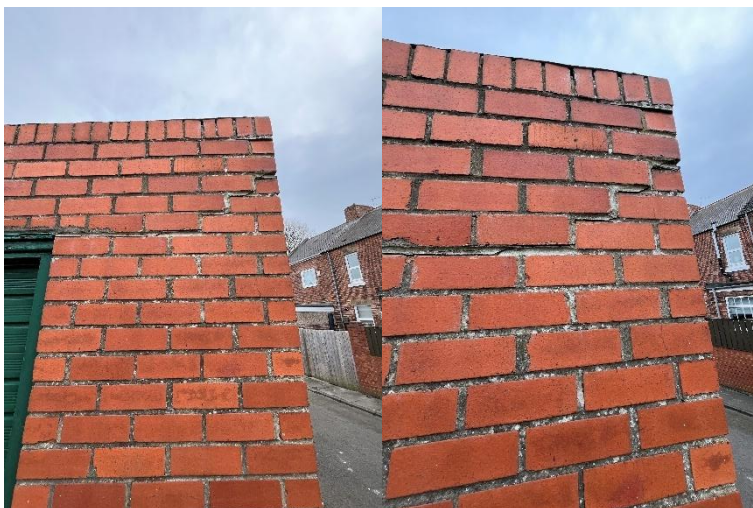
The masonry has diagonal cracking to the front elevation. Diagonal cracking can indicate structural movement. It is advisable to obtain further advice from a Structural Engineer regarding the structural movement. The Engineer may suggest monitoring or repair works to the structure.

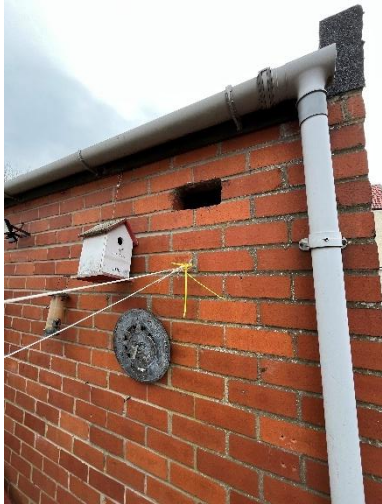
The brickwork will need to be replaced to prevent vermin entry/cold bridging and possible brickwork instability.

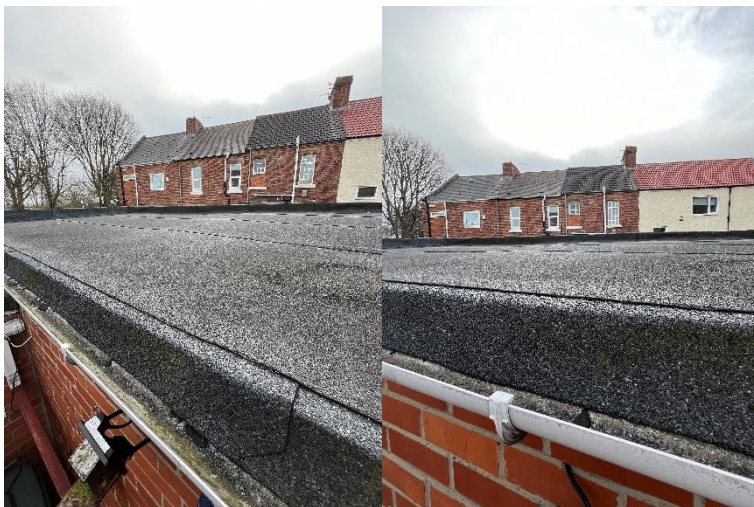
The felt roof appeared out of level, arching from front to back, this could have been caused by water ingress and the roof decking absorbing moisture. A roofing felt lifespan is between 10-20 years. The felt roof may be repaired to prevent water ingress to the garage roof timbers. An approved flat roofing contractor should be appointed to assess repair costs against recovering the entire roof covering.

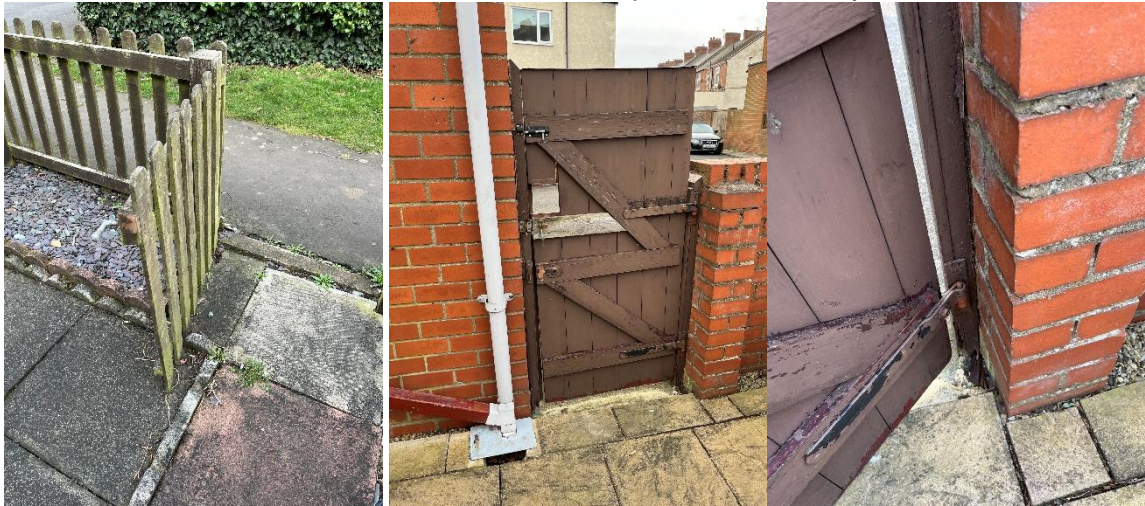
The front elevation is enclosed with a timber picket fence which is showing signs of timber decay and failure consideration should be taken to replace the fence line
