LEVEL 2

# Your survey report

18/11/2024

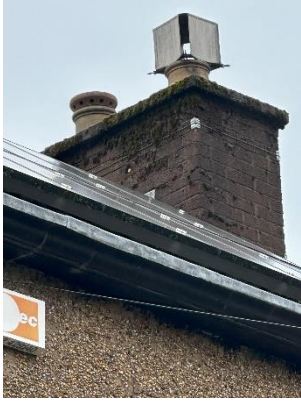
The chimney stack pot does not have a cover cap. A cover caps help reduce moisture and rainwater from entering the internal chimney structure when the chimney stack is not in use and prevents Internal damp patches forming. It is advisable that a competent person from the Heating Equipment and Testing Approval Scheme. (HETAS) installs a cover cap.

Missing cover

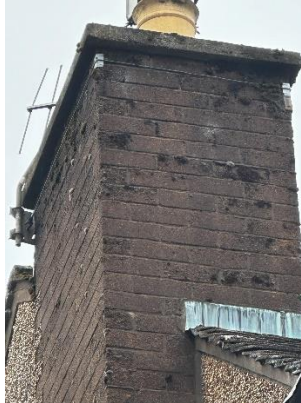
There was a significant amount of vegetation that is established to the mortar joints of the chimney stack. The vegetation will need to be removed to prevent future structural damage and mortar pointing may be required. A Gas Safe Engineer should be consulted for any works to the chimney stack and may have to undertake a flue smoke test.

Moss on chimney stack

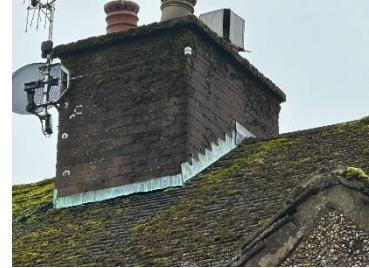
Moss on chimney stack

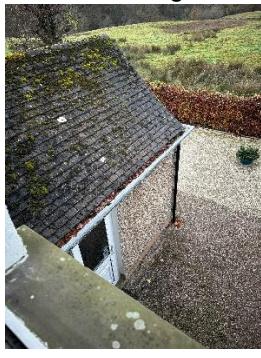
Vegetation in gutters

There appeared to be vegetation within the troughing channel. A blocked or restricted troughing channel can cause water to build and overflow to the rear side of the trough profile which may lead to internal damp patches or water penetration. The troughing should be cleaned at the first opportunity.

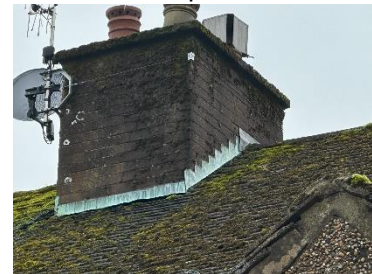
Moss and algae are beginning to form on the roof pitch, this is a relatively maintenance issue. However, the roof pitch will need to be cleaned in the future with a suitable moss and algae treatment. Moss can hold water, and when frozen can damage the surface of the roof pitch covering over time. Moss can also reduce ventilation which can increase condensation within the roof space.

Moss on roof

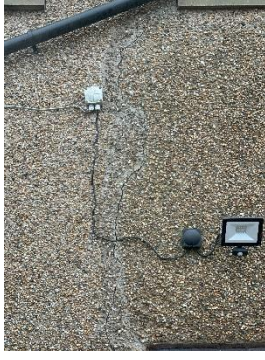
The pebble dash finish coat has minor cracking to several areas. This cracking may allow water to seep behind the coating which can further loosen or crack the coating during inclement weather. The cracked coating should be surface repaired or removed and then prepared to receive new render. The repair should be carried out by a suitably experienced and qualified person.

Thermal cracking of pebble dash

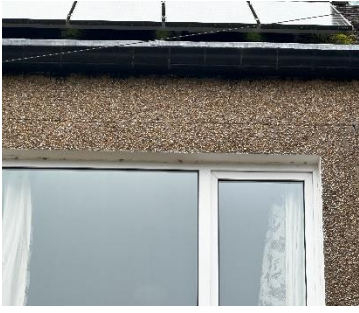
Structural cracking around lintel

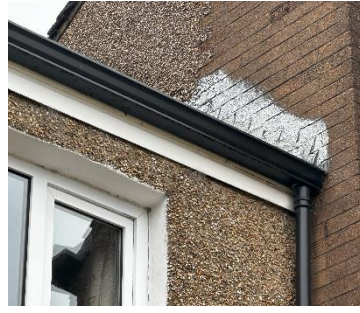
Paint/flash band repair

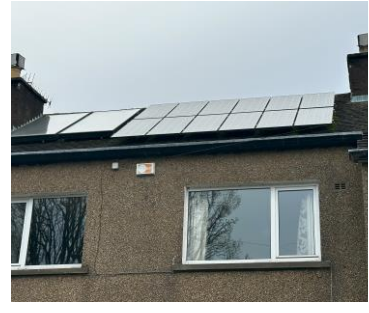
Minor cracking

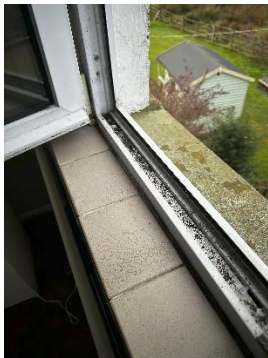
The wallpaper is water stained to the window opening. The window frame to the masonry junction should be checked for water tightness.

Leak to underside of window

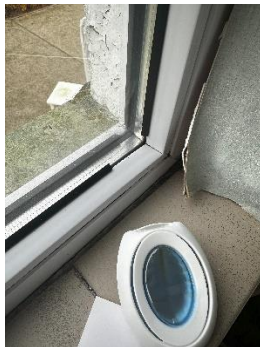
The window frame gasket is perished and has shrunk back. The window gasket acts as a waterproof seal between the frame and the opener and prevents cold draughts. The gasket should be replaced, (not all gaskets can be repaired due to the housing groove, and this results in a new window frame).

Shrunk gaskets

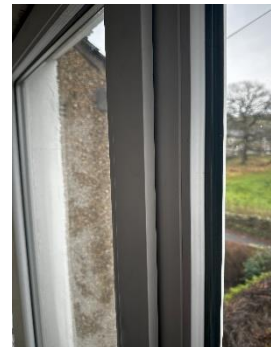
The side openers require adjustment as the opener is catch the frame. Openers that do not close into the frame rebate correctly can damage the opener hinge, double glazed unit, and the window frame.

Stiff closing

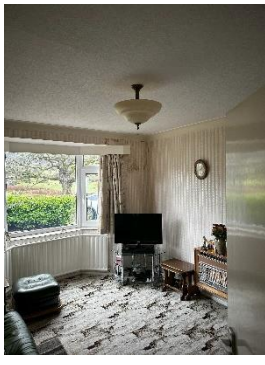
There is water staining to the plaster walls. The water source/ingress will have to be resolved before the walls can be replaced or suitably dried out and a stain block may have to be applied before redecoration. The plaster bonding should also be checked to determine if plaster works are required.

Water stain

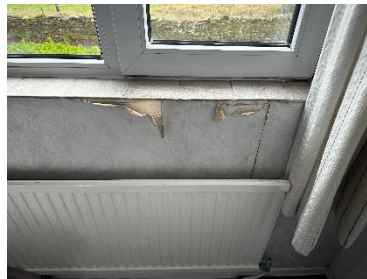
De bonded wall paper due to condensation

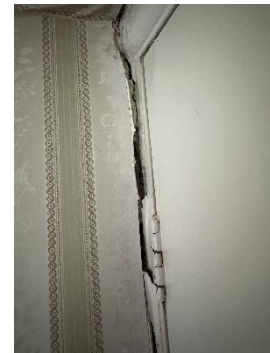
An opening had been formed and altered within the property to allow access to the extension. Cracking is observed to the door casing side and should be checked by a Structural Engineers. Checks should be made to ensure the alteration has been authorised by building control.

Structural movement

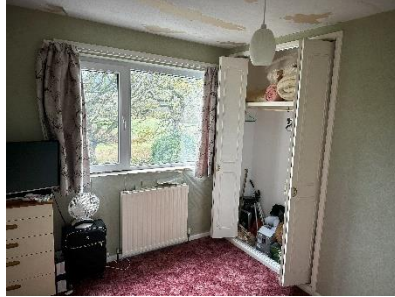
De bonded wall paper due to condensation

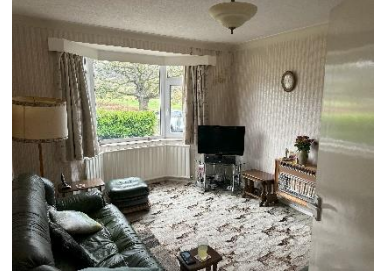
Water stain

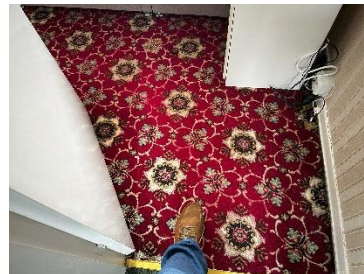
Some creaking and movement to the first floor was noted below the covering which will need to be refixed. Care should be taken when fixing flooring as wires and pipes are often hidden in floor voids and can be easily damaged

Movement under foot

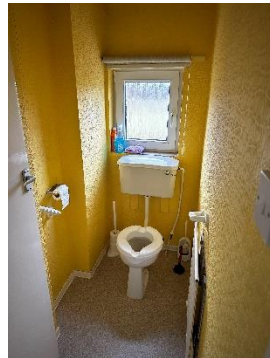
WC connect via lead waste
