LEVEL 2

# Your survey report

Inspection date 15/11/2024

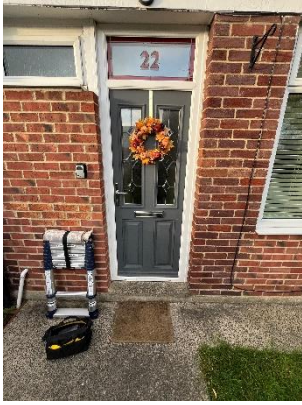
Pic1: Front Access door

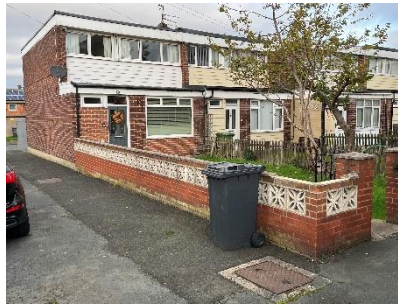
Pic2: View from front elevation

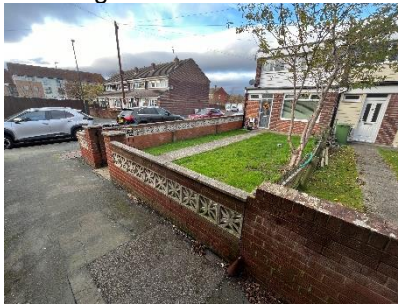
Pic1: Front Access Path

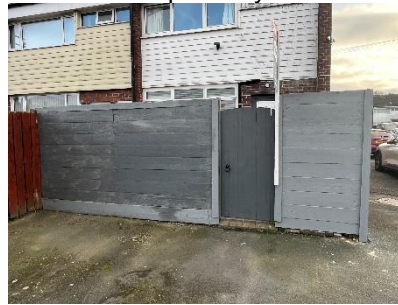
Pic2: Rear Access

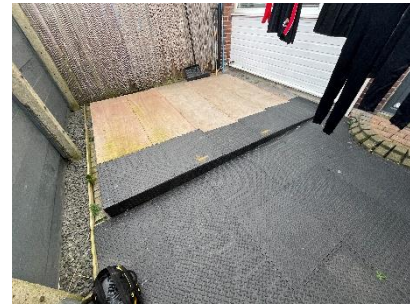
Pic3: Small rear yard

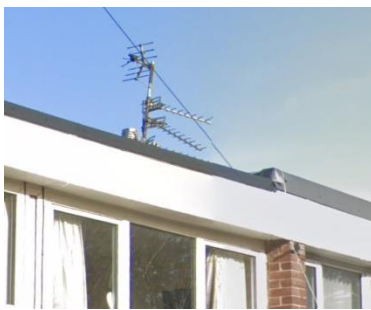
The property has a gas flue terminal this could only be partially seen due to the height restrictions.

Pic1: View of gas flue terminal

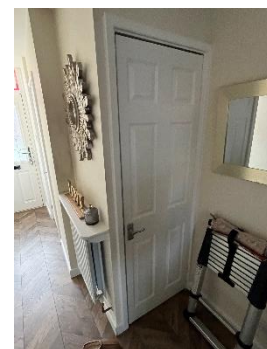
Pic7: door easement

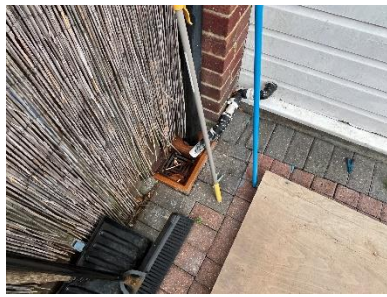
Pic4: Rear gully
