LEVEL 2

Your survey report

Inspection date

07/12/2024

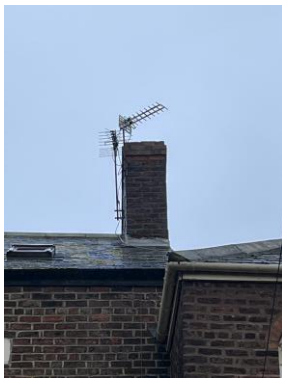
I could not see any structural defects from the pavement level, however, when repairs are next carried out to the roof it may be beneficial to have the chimney stack structure inspected more closely for stability.

Leaning chimney stack

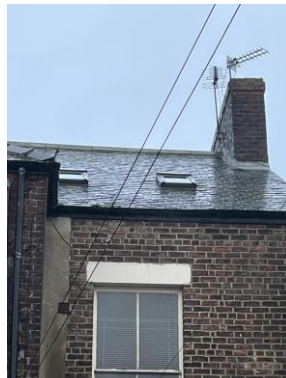
Leaning chimney stack

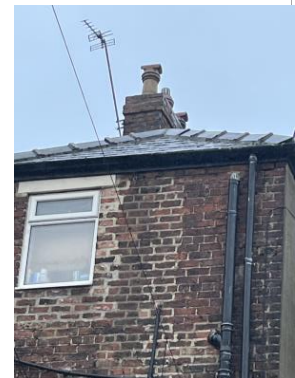
There were areas of missing mortar pointing to the chimney stack. The pointing will need to be replaced to ensure future stability of the masonry and to prevent damp or water entering the internal chimney stack.

Missing pointing

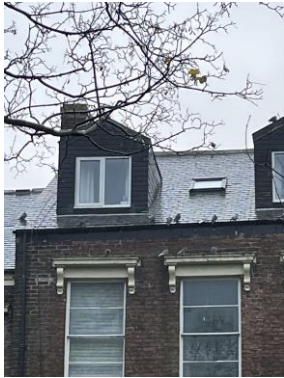
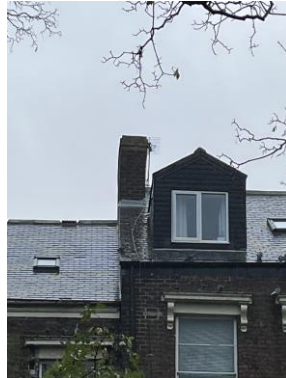
There are several slipped slates to the roof covering. The slate should be replaced and fixed to provide a watertight roof structure.

Slipped slate to left side of dormer

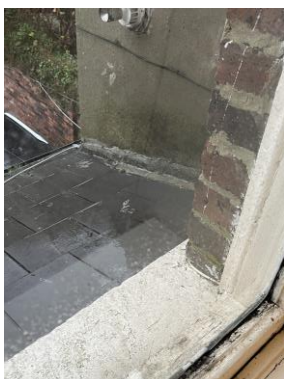
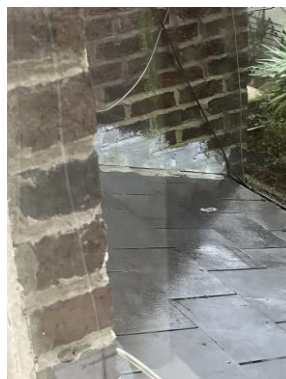
The lead flashing upstand is missing to the mono pitch to masonry junction. The upstand prevents masonry saturation. When the masonry remains saturated, damage can occur to the masonry face and pointing. The lead upstand should be replaced and cover or face the masonry by at least 75-100mm and return 150mm down the roof pitch.

Lead upstand missing

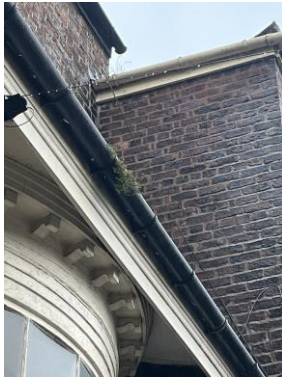
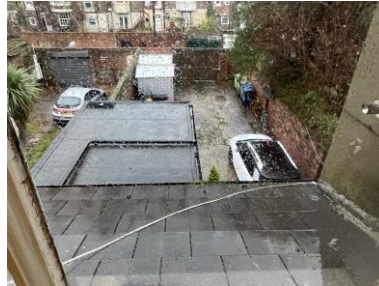
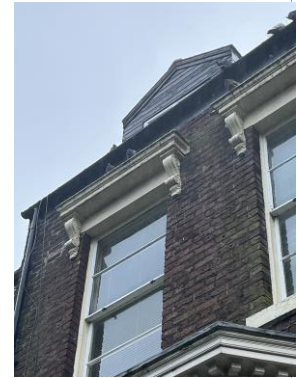
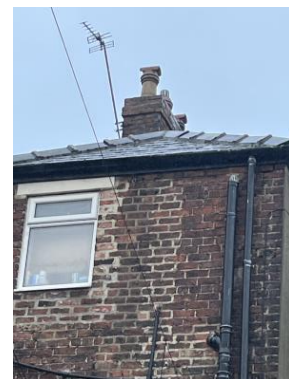
There appeared to be vegetation within the rainwater channel. A blocked or restricted gutter channel can cause water to build and overflow to the rear side of the guttering profile which may lead to internal damp patches or water penetration. The guttering should be cleaned at the first opportunity.

Vegetation in gutter

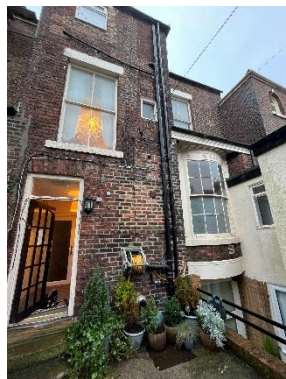
The cast rainwater downspout paintwork is peeled and has blistered. Costings for the rainwater downspout system should be obtained as the pipework may need to be replaced rather than repaired. Cast iron tend to rust to the masonry/backside which allows water leakage.

Blistered paintwork

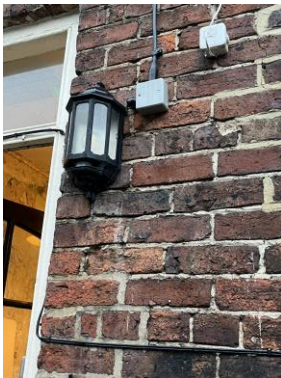
There are areas of brickwork that has defaced. Defaced brickwork can become porous, which may allow moisture and water ingress into the structure. The brickwork will need to be checked by a suitability qualified person experienced in assessing the remaining life span of masonry. Brickwork replacement may be considered or the application of an external render coat.

Defaced brickwork

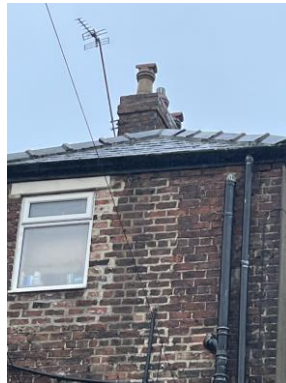
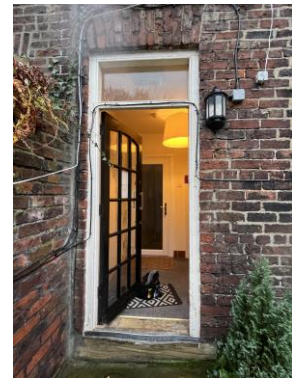
There are appears to be areas of surface pointing mortar (new mortar which is lighter in colour to the surrounding mortar and applied directly over the existing mortar). When applying new mortar, the mortar bed should be sufficiently removed/ground out in preparation to receive new mortar. The pointing will need to be fully checked to ensure the correct depth has been achieved, as surface pointing is prone to cracking and becoming loose. Loose and missing pointing has the potential to allow water ingress into the property.

Surface pointing

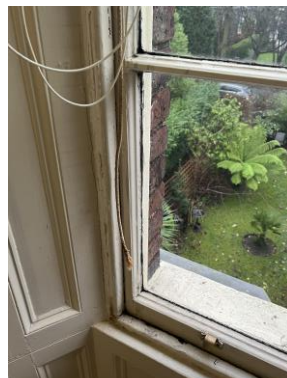
Sash weight ropes cut

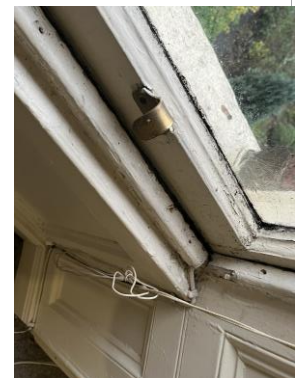
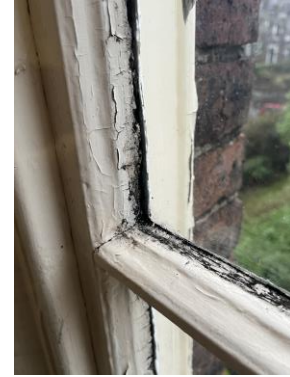
The paintwork to the window has peeled and blistered. The timber requires examining for timber decay and rot and treating/replacement if required. The timber should then be prepared for a new primer, base, and topcoat paint application. It is recommended the external decoration is recoated on a five-to-seven-year cycle.

Blistered paintwork

It is recommended to seek advice from a suitably qualified and experienced person scheme to assess the window condition repair works.

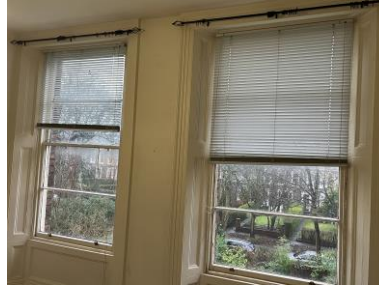
Windows appear out of square

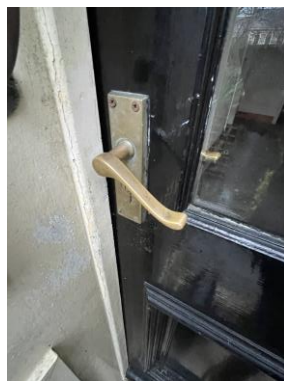
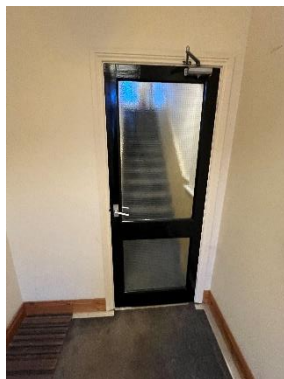
The door handle is suffering from wear and tear and now sits loosely with in its structure, this may need replacing in the near future to continue to be operational.

Front access door handle

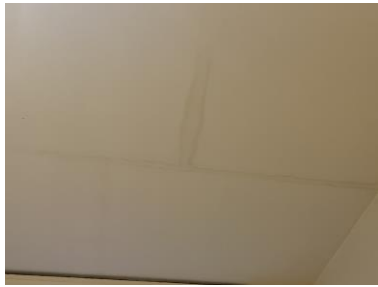
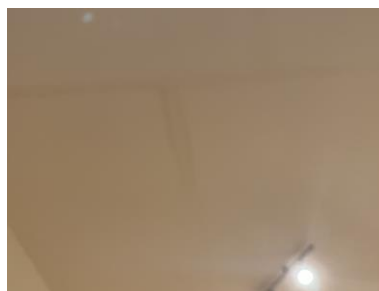
There is water staining to the ceiling. The water staining should be investigated to ensure there is no water leakage above the ceiling. The ceiling may also need a water stain block repair and redecoration.

Water-stained ceiling

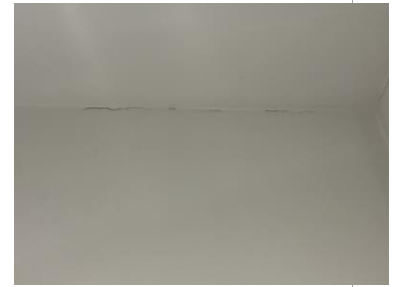
The paintwork to the bathroom ceiling has lifted due to moisture damage, checks should be made to the effectiveness of the mechanical extraction fan.

Bathroom ceiling lifted paintwork

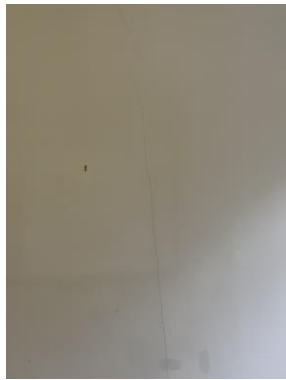
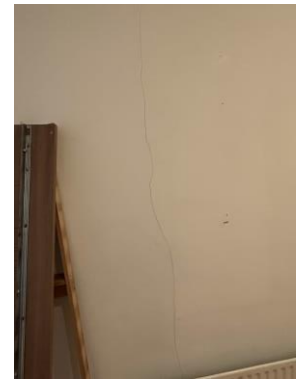
Thermal plaster cracking

Vertical thermal cracking

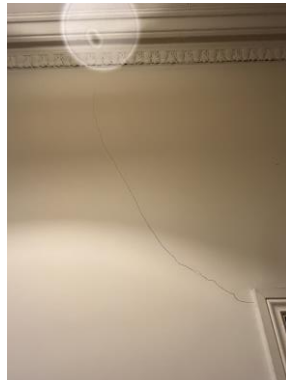
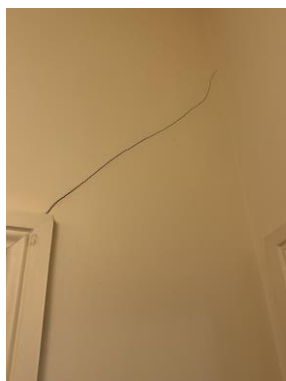
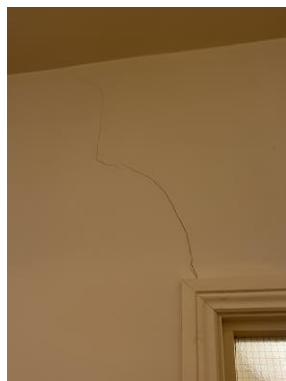
There was diagonal plaster cracking to the first-floor walls and is mirrored on either side of the wall. The plaster work has also de-bonded from the masonry wall. The plaster should be removed to determine if the cracks are also present to the masonry wall. Movement and cracking commonly occur to where the party or internal wall meets the external wall. A structural remedy is to provide lateral restraint L shape brackets in the wall internal corners. A Structural Engineer should be appointed should cracks occur to the masonry below the plaster surface.

Diagonal cracking above door

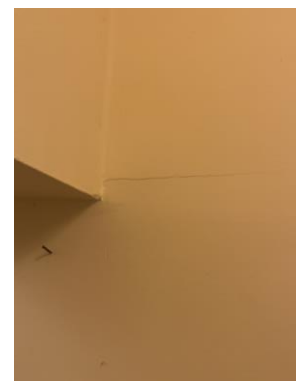
Horizontal crack near lintel

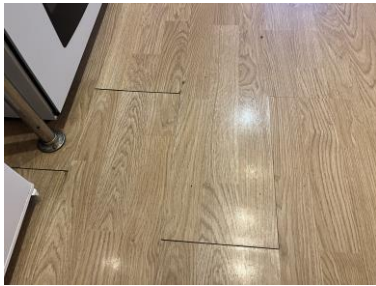
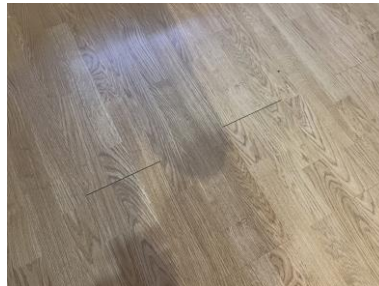
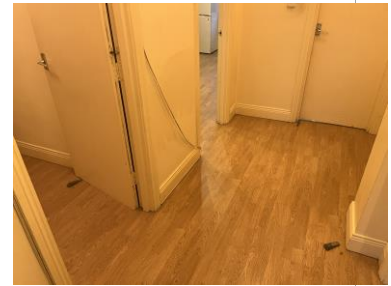
The laminate flooring is chipped, damaged and has moved in places. The flooring cannot be repaired, and a new floor covering may be required.

Swollen laminate

Slipped laminate

Laminate throughout flat

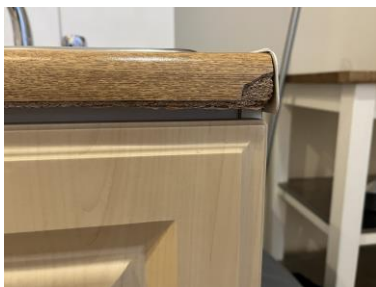
The worktop is heavily scratched and chipped. In time this will allow moisture or water into the worktop causing the chipboard to swell. The work top will need to be replaced or a surface medic may be able to undertake sealant and aesthetic repairs.

Damaged worktop

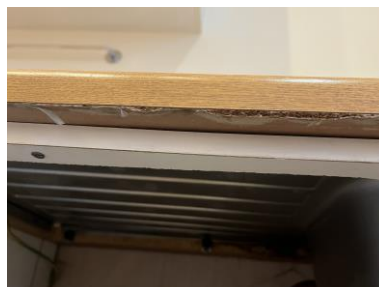
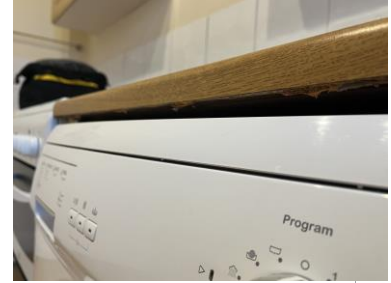
The worktop underside has swollen. The worktop will continue to absorb water/moisture and needs to be replaced.

Swollen worktop

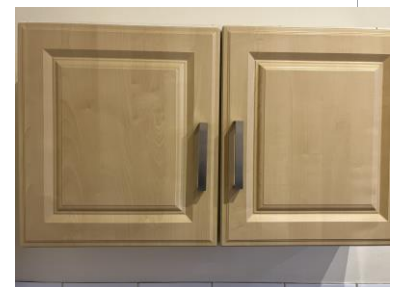
Several doors require realignment as this can cause the hinge to snap/come away from the unit.

Mis-aligned doors

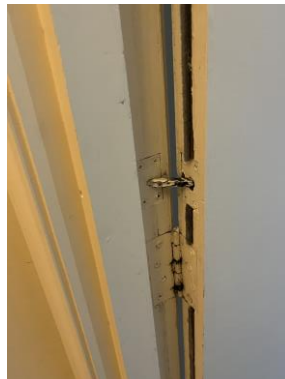
All habitable rooms have fired doors with self-closing devices and smoke seals installed, during the inspection it was noted that none of the doors operated correctly by self-closing into the rebate and latch in order to maintain adequate fire resistance, the doors may need to be re-fitted/eased by a competent person.

Self-closer is worn and painted

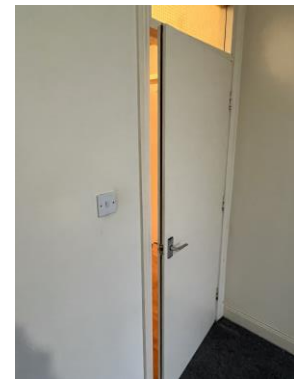
Living room door not latched

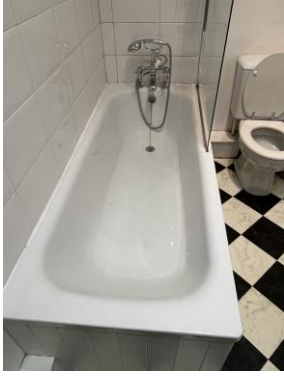
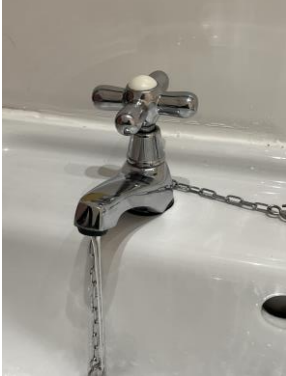
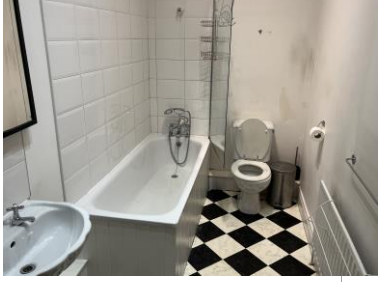
The wash hand basin tap is loose. The tap should be fitted in accordance with the manufacturer's instructions to prevent water leaks.

At the time of inspection, the bath plug was in and water present, we were unable to remove this as the reasoning is unknown, a competent person may be needed to ensure when it is removed not water will leak causing damage to other properties. NI

Water held in bath	Loose hot water tap	Discoloured paint work

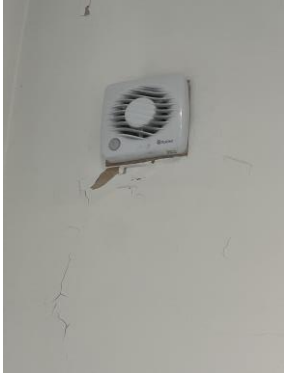
The shower screen seal does not meet the bath correctly and the seal should be replaced to prevent water damage to the bathroom panel and floor.

Blistered paint work around extractor	Show screen hard to operate	Poor silicone sealant will ne replacing

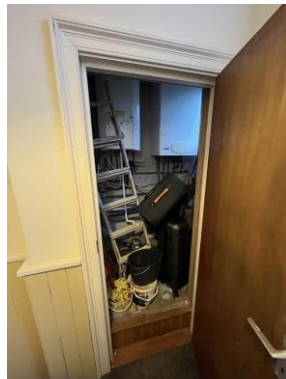
Storage in a fire risk area

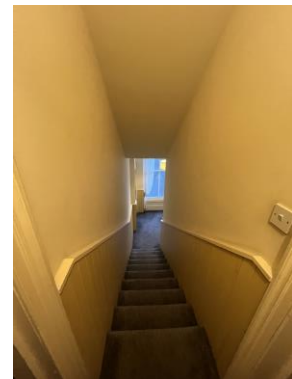
No hand holds to stair
