LEVEL 2

Your survey report

Inspection date 29/10/2024

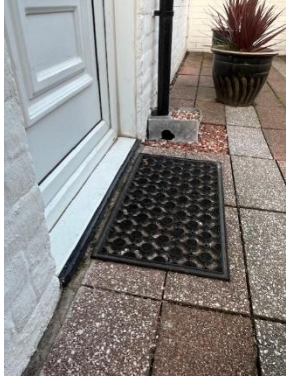
A damp-proof course (DPC) was not visible at ground level. Mortar should be removed to the bed joint to confirm a DPC has been incorporated in the construction. It was noted that a new path has been laid which reduces the height of the where the DPC should be installed (150mm above ground level) the new levels also reduce the upstand of the door threshold which would allow for the potential of rising damp.

Pic : Low upstand at front door
