LEVEL 2

Your survey report

Inspection date

11/12/2024

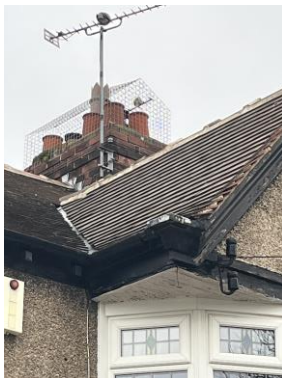
It appears from the ground level that the saddle flashing is missing (flashing to the chimney stack apex which is adjacent the ridge tiles). Lead work to a chimney stack structure protects the masonry from becoming saturated and forms a watertight junction between the roof covering and chimney stack structure.

Saddle flashing not visible

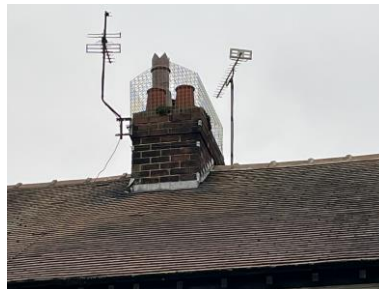
There is an area of vegetation to the structure. The masonry will need to be cleaned off when next undertaking maintenance work. Vegetation can hold water and when frozen can damage the masonry and mortar pointing. Pointing works may be required after the vegetation removal.

Vegetation to rear of chimney stack

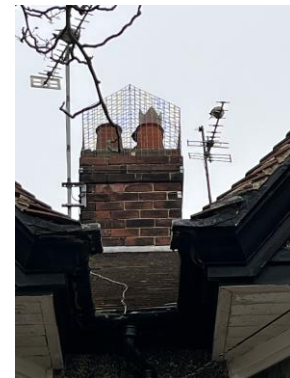
There were areas of missing mortar pointing to the chimney stack. The pointing will need to be replaced to ensure future stability of the masonry and to prevent damp or water entering the internal chimney stack.

Missing pointing on chimney stack face

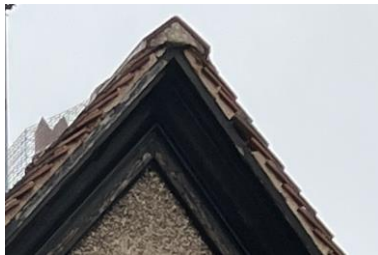
A section of verge pointing was cracked and missing to the roof line edge this is a relatively routine maintenance issue of wet roof applications. Should any damp patches appear inside the roof in the future, the mortar will need to be checked and replaced to ensure the structure is watertight and that the roof pitch tiles cannot be lifted in severe weather.

Missing Verge pointing

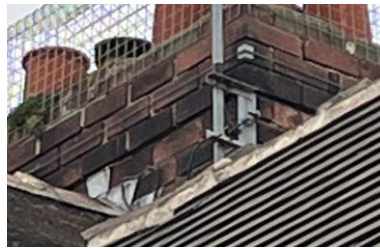
The mortar to the ridge tile was cracked and missing which has displaced the ridge tiles, this is a routine maintenance issue of wet roof applications. Missing and cracked mortar to the ridge tile can allow water ingress over time into the roof structure, and potentially unseat the tile from the roof covering during inclement weather. The remaining ridge tile mortar should be checked, and the missing mortar replaced.

Displaced ridge tiles

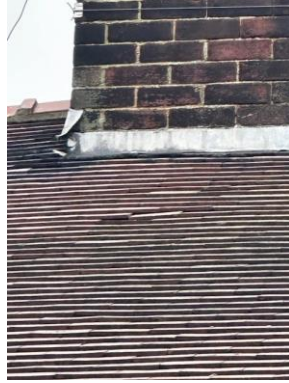
There are several slipped tiles to the roof covering. The tile should be replaced and fixed to provide a watertight roof structure.

Slipped tiles

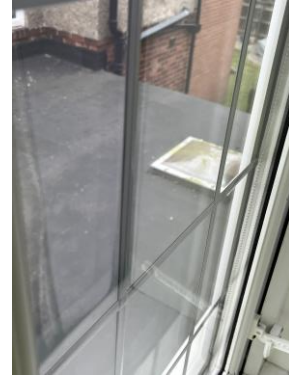
The flat roof membrane has been replaced, damage to the inside ceiling of the garage/utility is reported to be historic. A manufacturers/workmanship guarantee should be obtained prior to the completion.

Flat roof covering

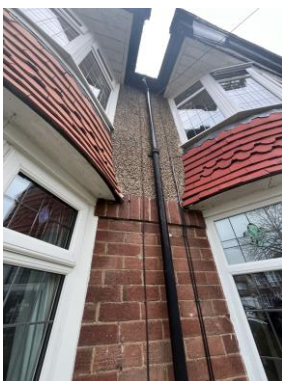
The cast rainwater downspout paintwork is peeled and has blistered. Costings for the rainwater downspout system should be obtained as the pipework may need to be replaced rather than repaired. Cast iron tend to rust to the masonry/backside which allows water leakage.

Cast iron downspout

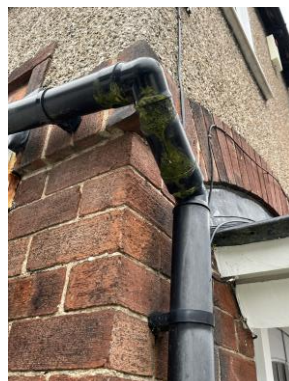
The rainwater downspout joint has a algae build up on the joint line which can indicate a defective seal, which is a relatively common maintenance issue. A leaking rainwater downspout over time can saturate/damage the masonry face during cold weather. The vegetation should be removed when next maintaining the outside of the property, and checks should be then made during inclement weather to ensure the joint lines are watertight.

Algae build up on waste

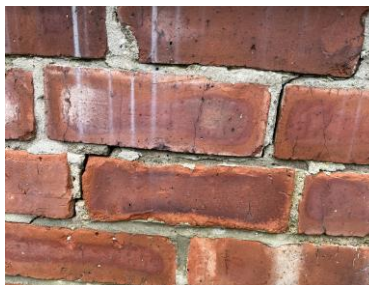
Stepped structural crack

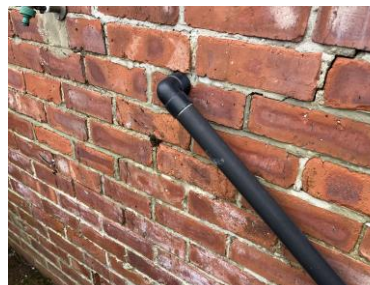
Structural crack extends across 16 courses

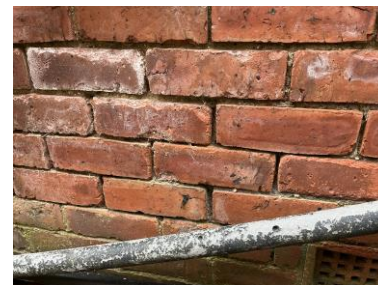
There were areas of missing mortar. The mortar will need to be replaced to prevent water ingress which can lead to damp and water staining internally. All elevations of brickwork pointing should be checked.

Missing pointing

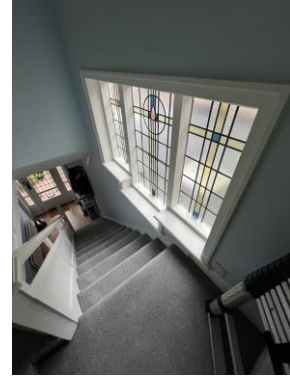
Low level glazing should be protected from the impact of persons falling or the glazing to be sufficiently graded to avoid damage toughened and laminated, although this was not a regulation at the time of build, consideration should be made to this if or when glazing in critical areas are replaced

Low level glazing

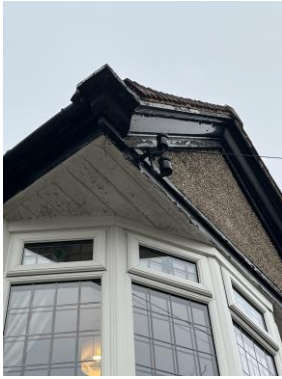
The paintwork to the fascia board have peeled and blistered. The timber requires examining for timber decay and rot and treating/replacement if required. The timber should then be prepared for a new primer, base, and topcoat paint application. It is recommended the external decoration is recoated on a five-to-seven-year cycle. Repairing roofline timbers requires scaffold access equipment (which can be costly). I would recommend obtaining estimates of works from competent contractors before the exchange of contracts.

Blistering Fascia boards

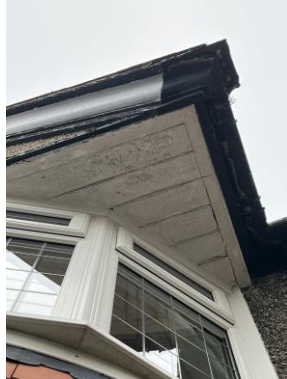
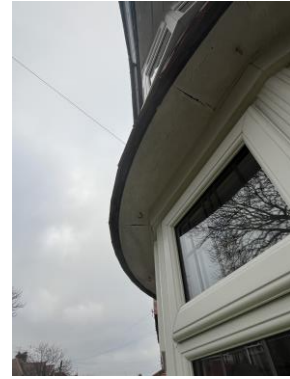
The paintwork to the soffit timber boards have peeled and blistered. The boards should be checked for timber decay and rot. It is recommended the external decoration is recoated on a five-to-seven-year cycle.

Blistering soffit boards

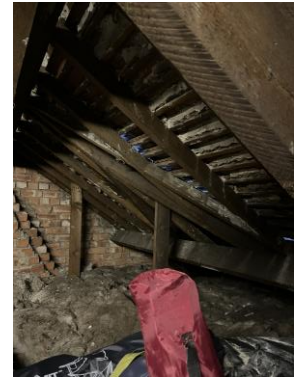
The main roof does not have an underfelt. A felt is designed to act as a secondary rainwater barrier to the roof covering. Water ingress from the roof covering can cause timber decay and damage to electrics and to the ceiling plasterwork below. It is advisable to 're-roof' the main roof with a breathable felt system and new battens. The roof structure timbers should be examined once exposed.

Visible daylight between tiles

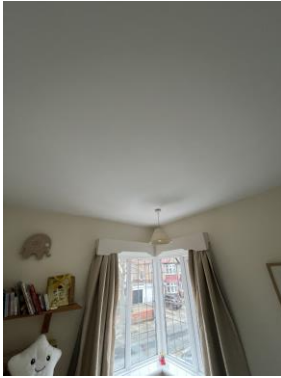
There is cracking to the bedroom, hallways and kitchen ceilings. The cracking may be repaired with a decorator's filler/plaster filler product and repainted. The crack may reappear over time.

Front bedroom ceiling

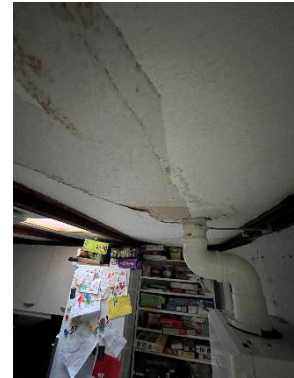
The utility ceiling has collapsed. The ceiling material will have to be removed and repaired with a plasterboard with a plaster skim before redecoration the ceiling. New ceilings and areas of ceiling replacement, create significant disruption, and walls will also require plaster repair works because of replacement ceilings. The room may also require re-painting.

Utility ceiling

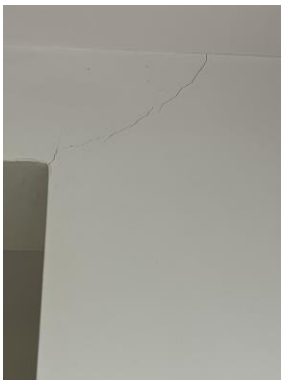
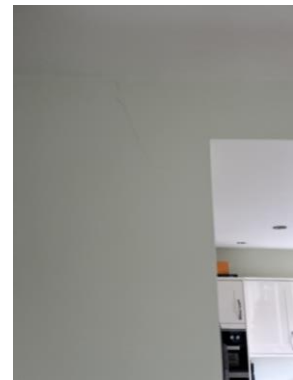
There were diagonal plaster cracking above opening heads. The plaster should be removed to determine if the cracks are also present to the masonry wall. Movement and cracking commonly occur to where the party or internal wall meets the external wall. A structural remedy is to provide lateral restraint L shape brackets in the wall internal corners. A Structural Engineer should be appointed should cracks occur to the masonry below the plaster surface.

Diagonal cracking

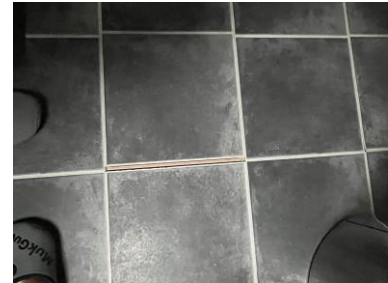
The laminate flooring in the utility is damaged in places. The flooring cannot be repaired, and a new floor covering may be required.

Utility floor damage

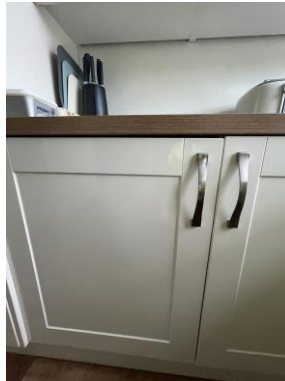
Doors need realigning

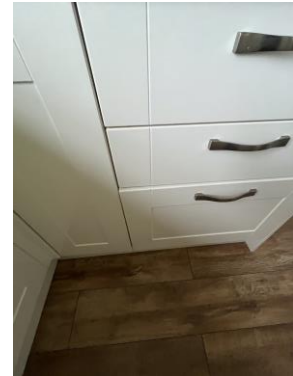
Drawers need realigning

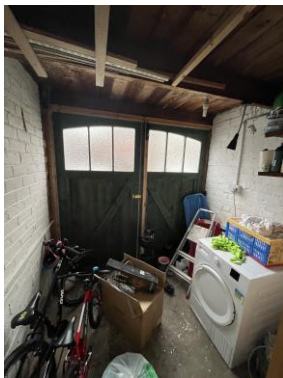
Evidence of water damage

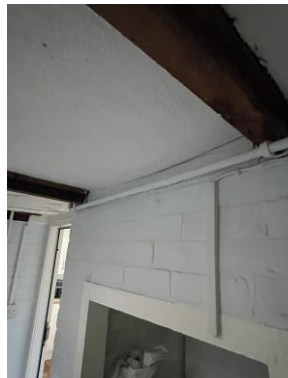
Damage to ceiling

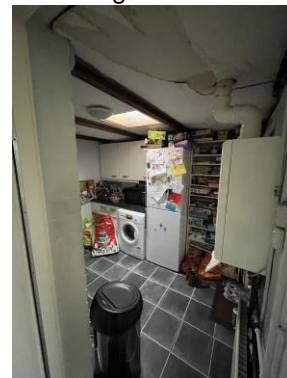
Collapsed ceiling

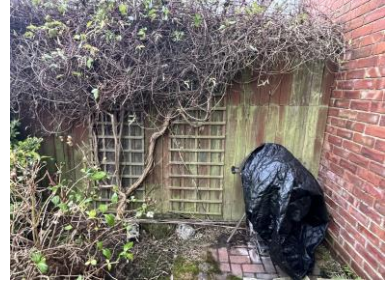
Timber decay to fence line

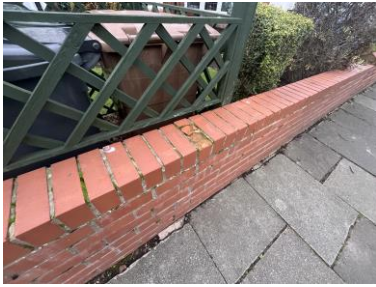
The boundary walls need repair works.

Damaged brickwork

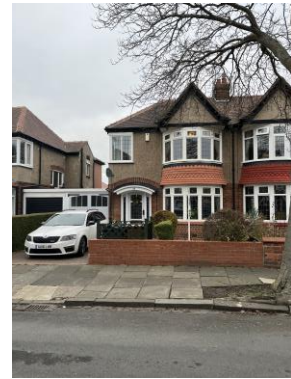
Uneven public footpath
