Your survey report

Property address: [REDACTED]

Inspection date 02/11/2024

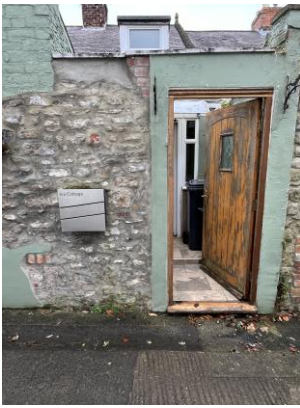
Timber door leading to back lane

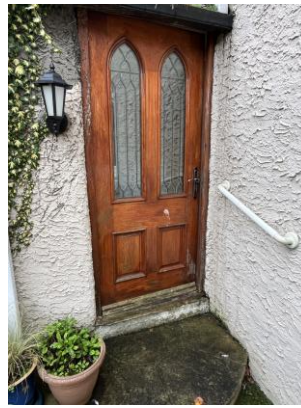
Timber front door
