Your survey report

07/03/2025

D2 Roof coverings

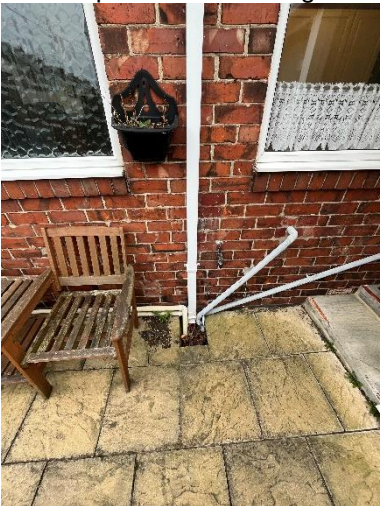
The gulley should be cleaned as there is a build-up of vegetation within the gulley profile. A blocked gulley does not allow rainwater to be discharged correctly into a drainage system. Excessive, concentrated rainwater that is not drained correctly can affect the external levels and has the potential to damage foundations.

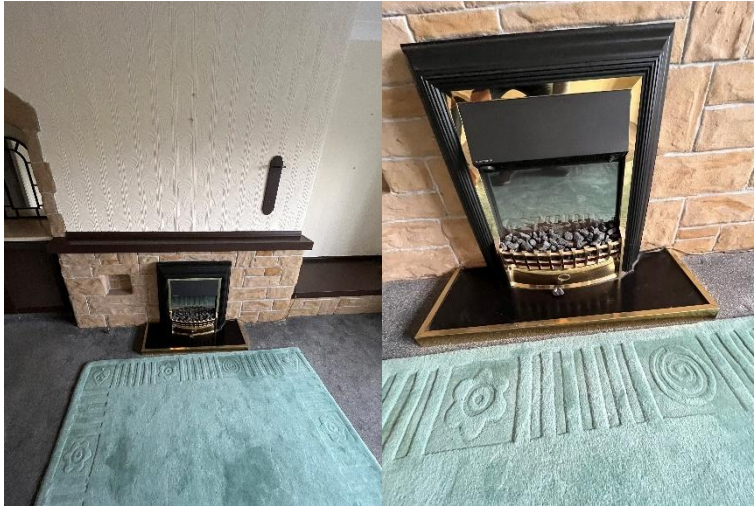
E5 Fireplaces, chimney breasts and flues

The electric fire was not inspected.

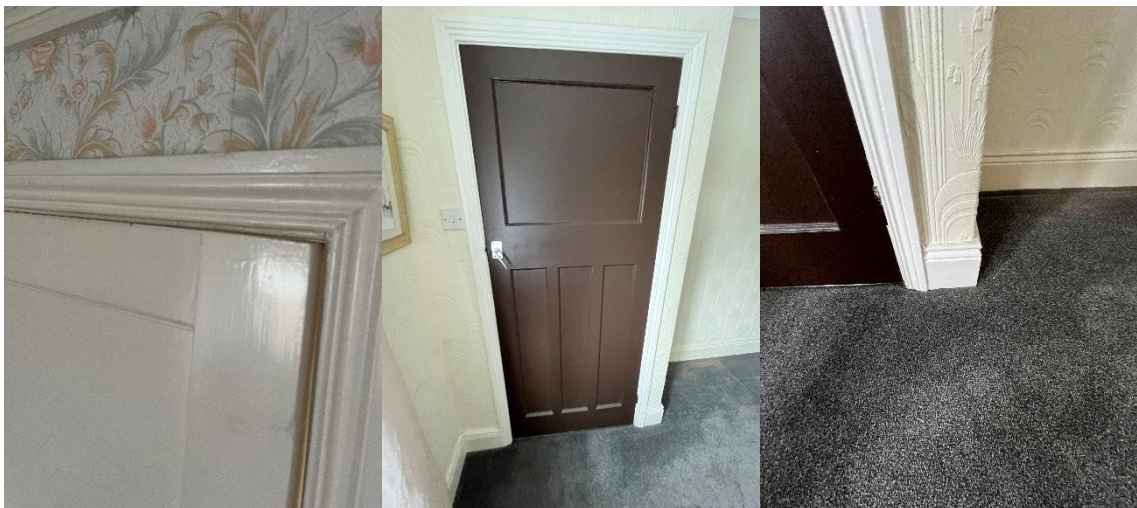
There are several doors that do not close correctly. The doors may need to be re-fitted/eased by a competent person.

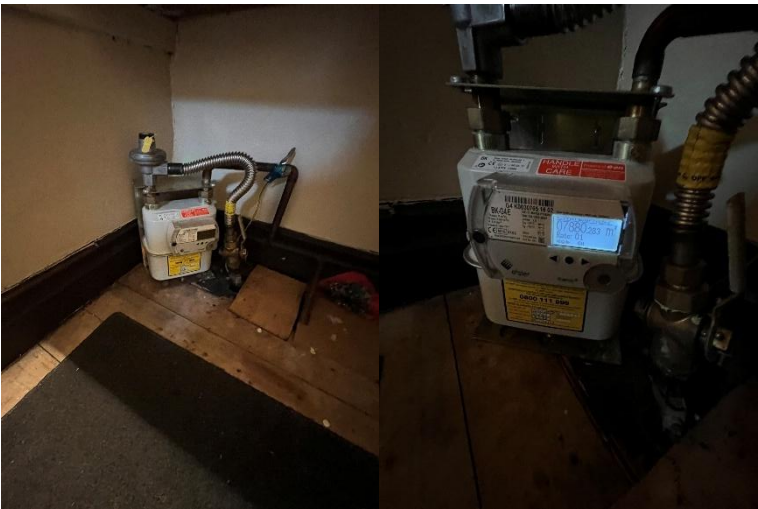
The gas meter was located in the understairs cupboard

We have not tested the gas and heating system and cannot confirm its condition. (Please refer to the service limitations to inspection)

Safety warning: All gas and oil appliances and equipment should be regularly inspected, tested, maintained and serviced by a registered 'competent person' in line with the manufacturer's instructions. This is important to make sure that the equipment is working correctly, to limit the risk of fire and carbon monoxide poisoning, and to prevent carbon dioxide and other greenhouse gases from leaking into the air. For more advice, contact the Gas Safe Register for gas installations, and OFTEC for oil installations.

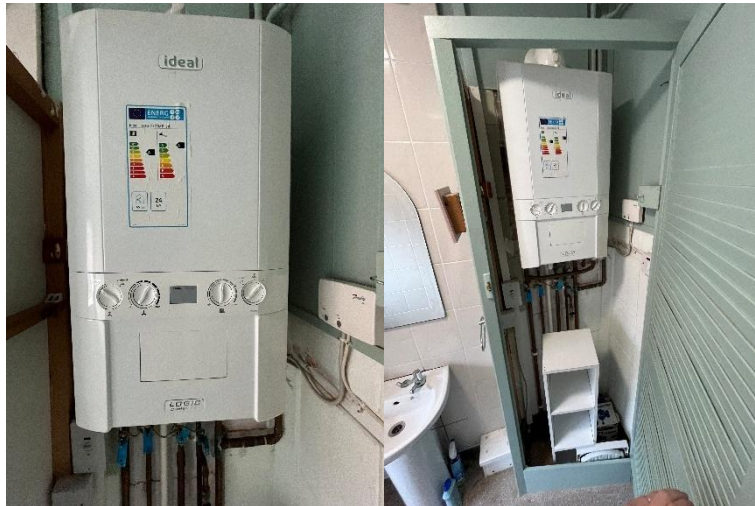
The hot water tap was checked in the kitchen, however hot water was not provided. A competent person should check the water heating, at the time of the survey the boiler was not operational.

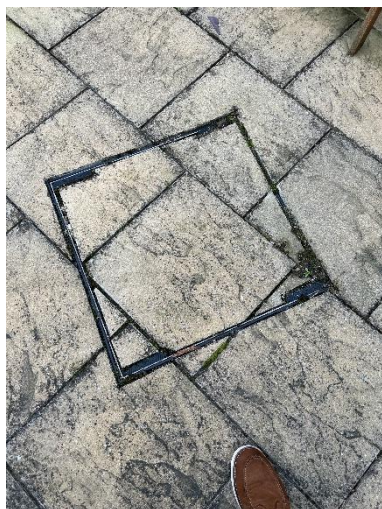
F6 Drainage

We attempted to inspect the drainage system, however the drainage cover was not readily removable.
