LEVEL 2

Your survey report

Inspection date

07/12/2024

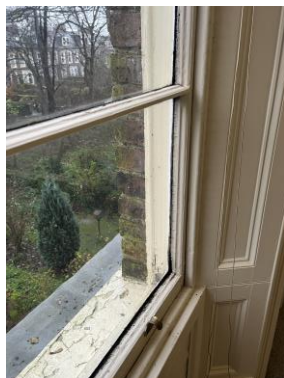
Single glazed windows

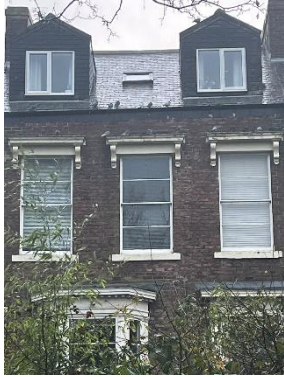
Windows appear out of square

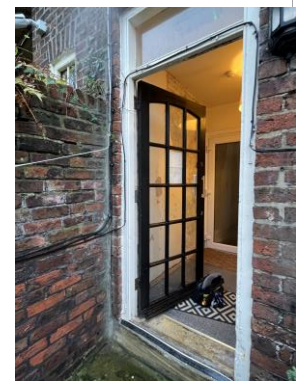
Rear access door

Internally within the common areas, fire doors appear to be twisted and do not close flush into the reveals with the self-closing devices.

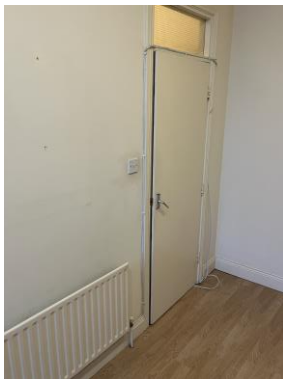
Fire doors are installed to ensure the residents with in the building are able to remain safe in the building or during emergency evacuation.

Kitchen door not latched

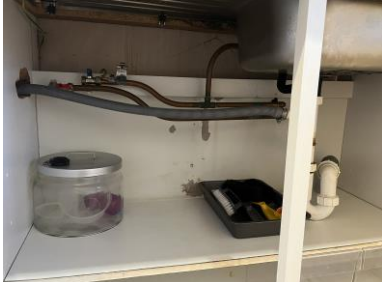
A mains water supply is provided to the property. Where accessible the pipework appeared to be in plastic and copper. You should ensure that the stopcock should be kept accessible so that it can be accessed in the event of an emergency to cut the water supply off.

From our visual inspection of the water supply and plumbing the systems appears satisfactory, however before using the system, the water should be run through to ensure any stagnant water conditions are avoided and to minimise the possible build-up of any bacteria.

Pipework no visible leaks

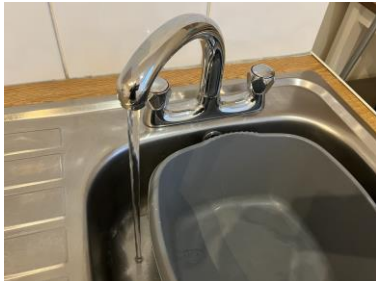
The hot water tap was checked in the kitchen, however hot water was not provided. A competent person should check the water heating.

Running hot water

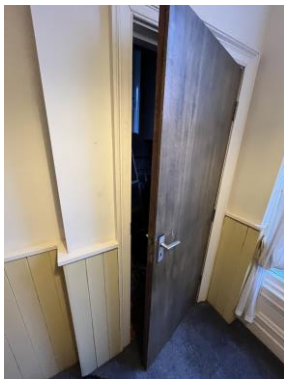
Boiler cupboard left open
