LEVEL 2

Your survey report

Inspection date

11/12/2024

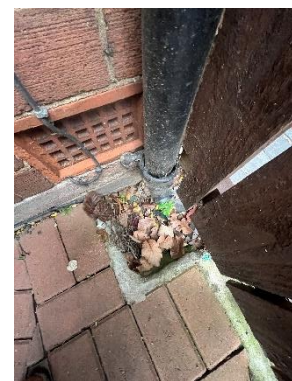
Discharge into gully

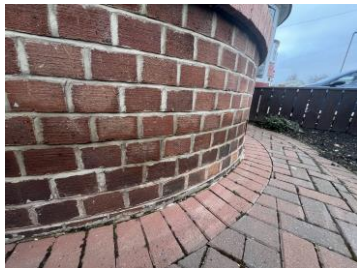
There were areas of missing mortar. The mortar will need to be replaced to prevent water ingress which can lead to damp and water staining internally. All elevations of brickwork pointing should be checked.

New pointing to bay brick work

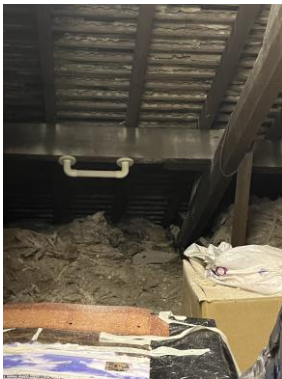
Displaced insulation blocking ventilation

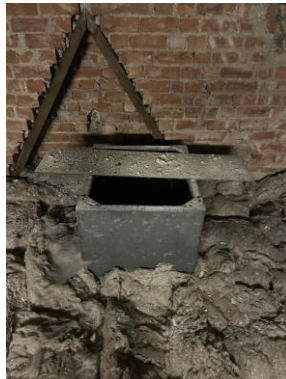
Redundant water tank

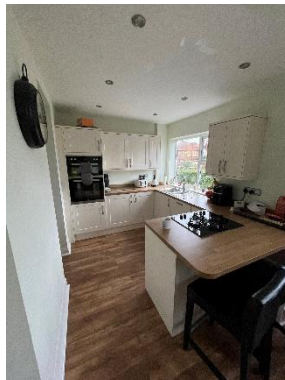
Internal wall removed

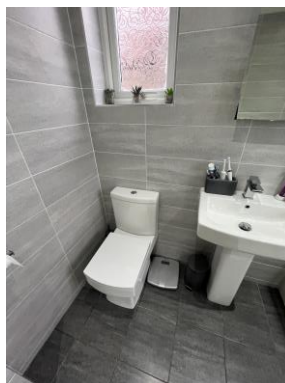
WC and Wash hand basin

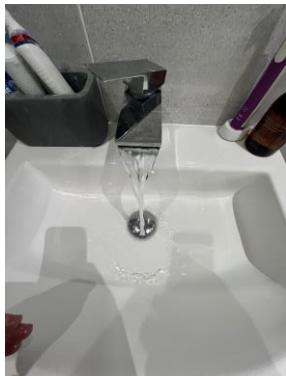
At the time of the survey the hot water tap was checked in the kitchen and bathroom, hot water was provided.

Bathroom hot water tap
