LEVEL 2

# Your survey report

Inspection date 28/11/2024

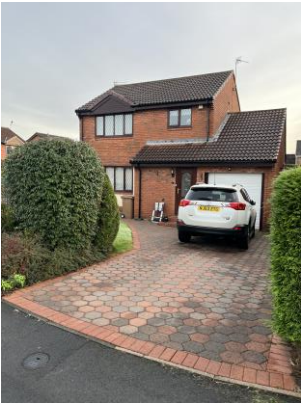
Pic1: Driveway

The property has a medium sized garden area with shrubs and metal railings/fence bordering the footpath. Access to the property is via a block paved driveway which also leads to an integral garage.
