LEVEL 2

Your survey report

Inspection date

11/12/2024

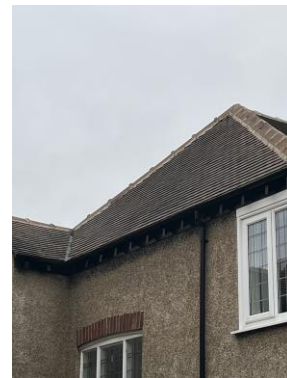
Valley

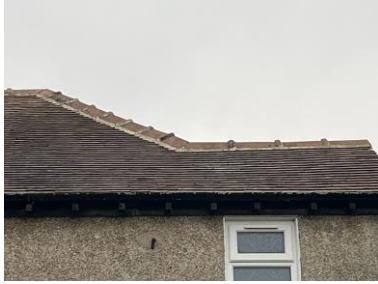
Ridge tiles have been repointed

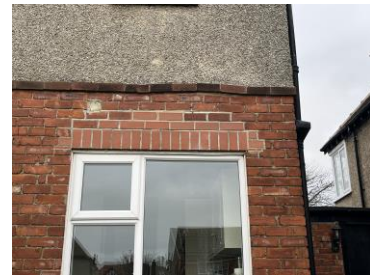
An opening has been increased in size in order to install a larger window after the original property construction. The brick work has been cut and removed. This may have resulted in masonry tie wires being removed and the damp proof course being damaged.

New enlarged opening

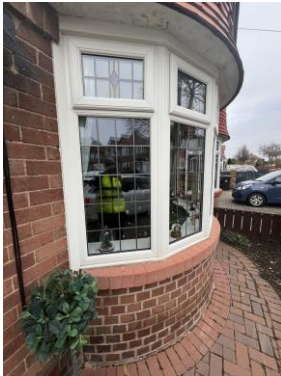
Bay window

Low level glazing should be protected from the impact of persons falling or the glazing to be sufficiently graded to avoid damage toughened and laminated, although this was not a regulation at the time of build, consideration should be made to this if or when glazing in critical areas are replaced

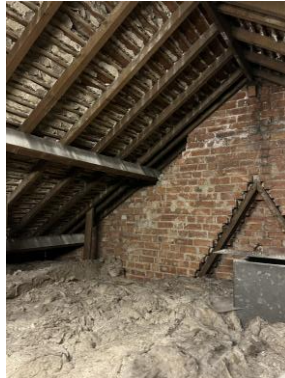
Unfelted rood structure

It is advisable to appoint a reputable roofing contractor that is registered with the National Federation of Roofing Contractors or an approved governing body to assess the entire roof covering (including elevations and extensions) condition, ventilation, repair costs and remaining product/material lifespan before the exchange of contracts.

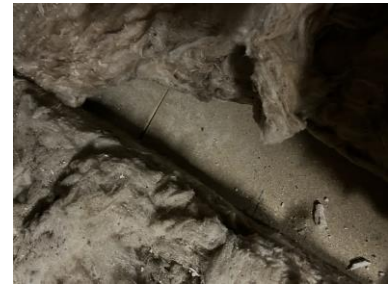
Boarded loft with insulation laid over

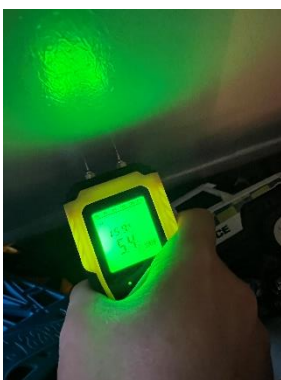
5.4%-meter reading

Due to furnishing limited moisture readings could be taken all showed and acceptable level of less than 10%

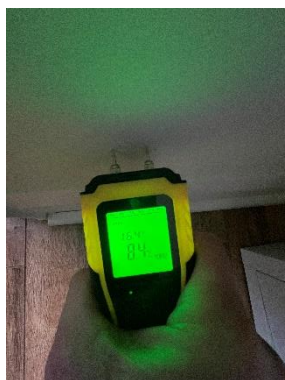
8.4%-meter reading

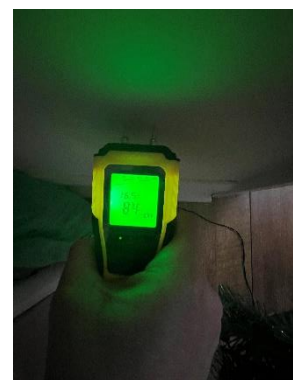
8.4%-meter reading

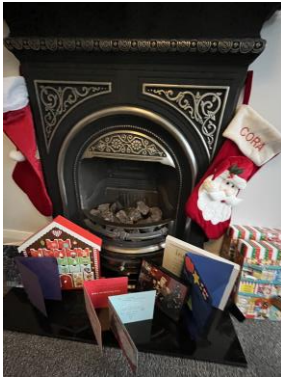
There is a fitted gas fire in the living room, this was not tested. Your Legal Advisers should make enquires on annual inspection/service records. It is advisable to inspect gas appliances on an annual basis. A rating of three would be applied if the gas appliance had not been serviced or inspected in the last twelve months.

Gas fire

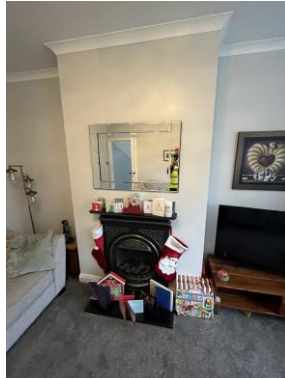
The chimney stack is no longer in use. It is recommended for redundant chimney stacks to be ventilated to each room and the terminal. This allows any moisture that penetrates the chimney stack masonry and potentially runs down the chimney flue, to be ventilated upwards externally with the air flow change. Chimneys stack flues are stained with coal and soot deposits which soak up moisture, resulting in internal damp patches to the chimney plaster. It is recommended to ventilate the chimney stack should wet staining occur to the plasterworks. A competent HETAS approved chimney specialist will be able to provide further advice and costs.

Living room chimney

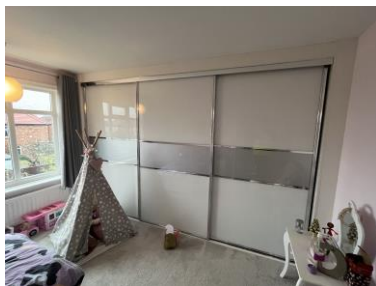
The wardrobes are a bespoke construction and are functional. Minor repairs such as hinge realignment and securing of handles are required periodically with all built in wardrobes.

Built in wardrobes

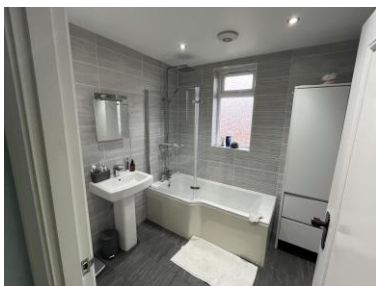
Bathroom suite

The shower head should be suitably cleaned, and hot water should be run through the system to ensure bacteria such as legionella is not present. NI

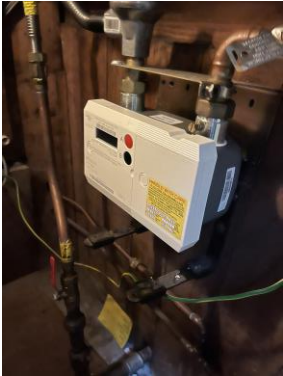
The gas meter was located under the stairs, accessed by a small cupboard with the utility room
We have not tested the gas and heating system and cannot confirm its condition. (Please refer to the service limitations to inspection)

There was not a gas safe certification available at the time of our inspection. Due to the potential of serious harm and injury resulting from a gas fault or carbon monoxide poisoning, the condition report has been scored as a three. The score is to emphasise the importance of obtaining a current gas safe certificate. All gas-enabled appliances and all gas fittings must be checked by a registered gas safe engineer before the exchange of contracts.

Gas meter

A gas safe engineer can also provide a condition report of the remaining service life to the system and provide costings for any remedial works, prior to the exchange of contracts.

It is also advisable to install a carbon monoxide tester to every room with a gas appliance. It is also advisable to test the detector on a regular basis.

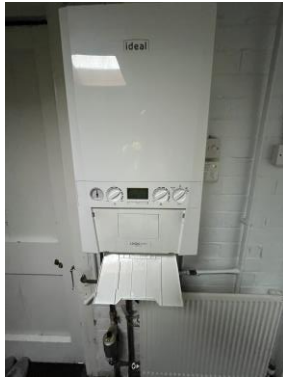
There was not a current boiler service certificate available at the time of our inspection. It is advisable before the exchange of contracts to obtain a boiler service certificate which includes a condition report on all radiator components.

The heating comprises of a traditionally pumped hot water system with radiators linked by copper/plastic pipes. The heating to the radiators was on at the time of the survey.

Boiler

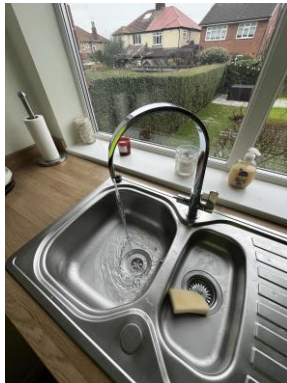
At the time of the survey the hot water tap was checked in the kitchen and bathroom, hot water was provided.

Kitchen hot water tap

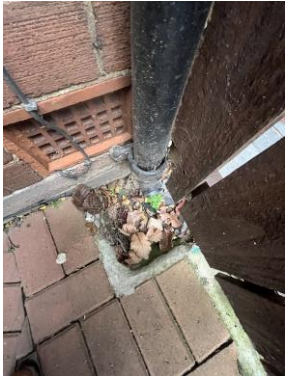
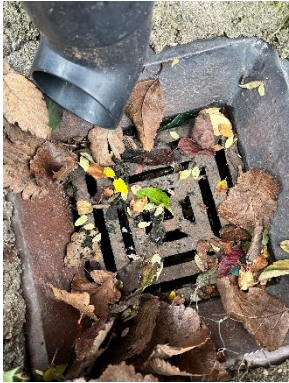
<p>There were no visible inspection chambers within the property boundary, therefore the underground drainage has not been inspected.</p> <p>The gulley should be cleaned as there is a build-up of vegetation within the gulley profile. A blocked gulley does not allow rainwater to be discharged correctly into a drainage system. Excessive, concentrated rainwater that is not drained correctly can damage foundations over time and external levels.</p> <div data-bbox="469 846 754 1223">

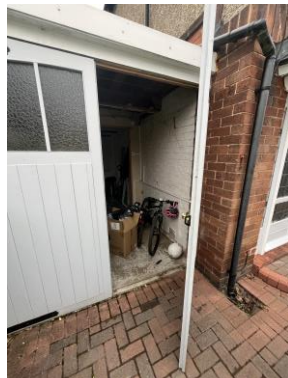
Front access

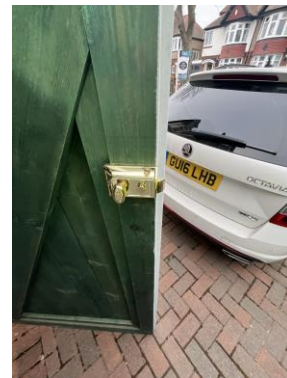
Locking mechanism

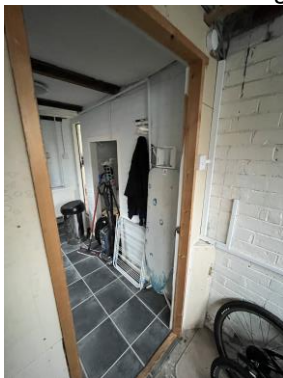
Non fire rated separation

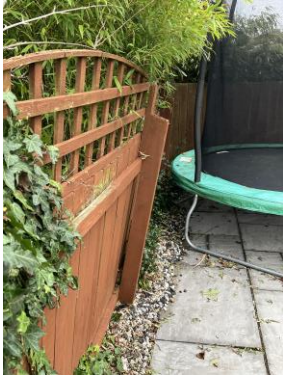
The rear elevation is enclosed with timber posts, timber rails and timber palings. The fence line is showing signs of wear and tear, the rear fence line boundary has also moved and requires repairs. The fence timbers need to be maintained, repaired, and replaced as necessary.

Collapsed fence line

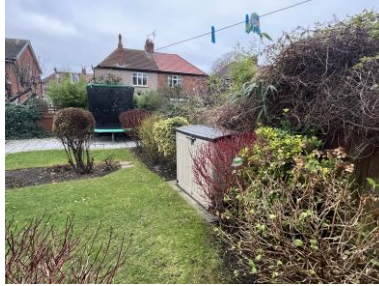
Rear boundaries

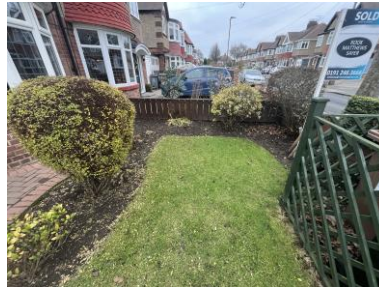
Timber fence line
